SPE-210607-MS

A Return to Production: Subsea Packer Leak Remediation with Pressure-Activated Sealant

Austin Tyler Burgess, Seal-Tite International; Colin Hosli and Kevin Whittaker, Shell Exploration & Production Company

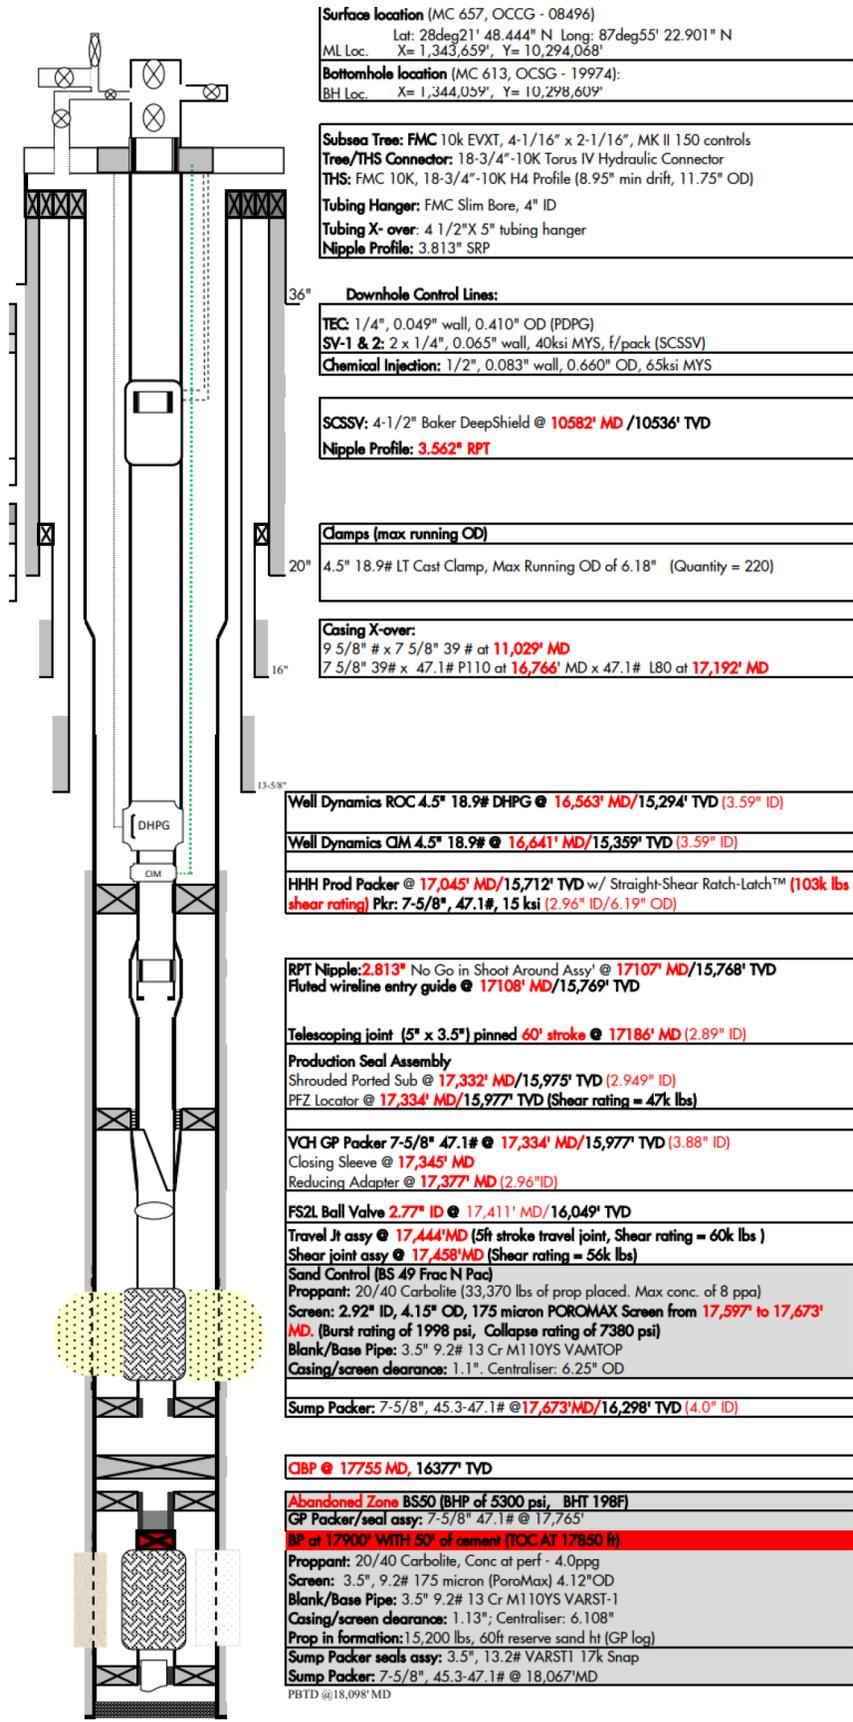
Figure 1—Subject Well Completion Schematic

The newly recompleted well (See [Figure 1](#) below for completion drawing) stayed on production for approximately two years before the operator identified a leak through observed annular pressure loss. The liquid leak rate was estimated to be approximately 58 L/day. This triggered an investigation into the potential leak locations and failure mechanisms, which included eight leak path possibilities:

The leak path from the A-annulus to tubing was initially expected to be near the SCSSV. During diagnostics, when A-annulus pressure was bled down to below tubing pressure, annulus pressure began to build, indicating an influx of tubing fluids. Without gathering additional diagnostic data, there was uncertainty around the depth of the leak. The leak was estimated to be close to the SCSSV, based on A-annulus/ tubing gradient intersection and the assumption that the system was in hydraulic equilibrium. An extended flow test diagnostic was performed from 2/26/2020 to 3/23/2020 to assess the leak rate under varying production rates of ~10, ~20, and ~30 mmscfd. The test concluded that the leak rate was operationally manageable while flowing at all rates. A-annulus pressure was managed by topping up with methanol as needed to maintain the pressure between 2900 psi and 4500 psi.

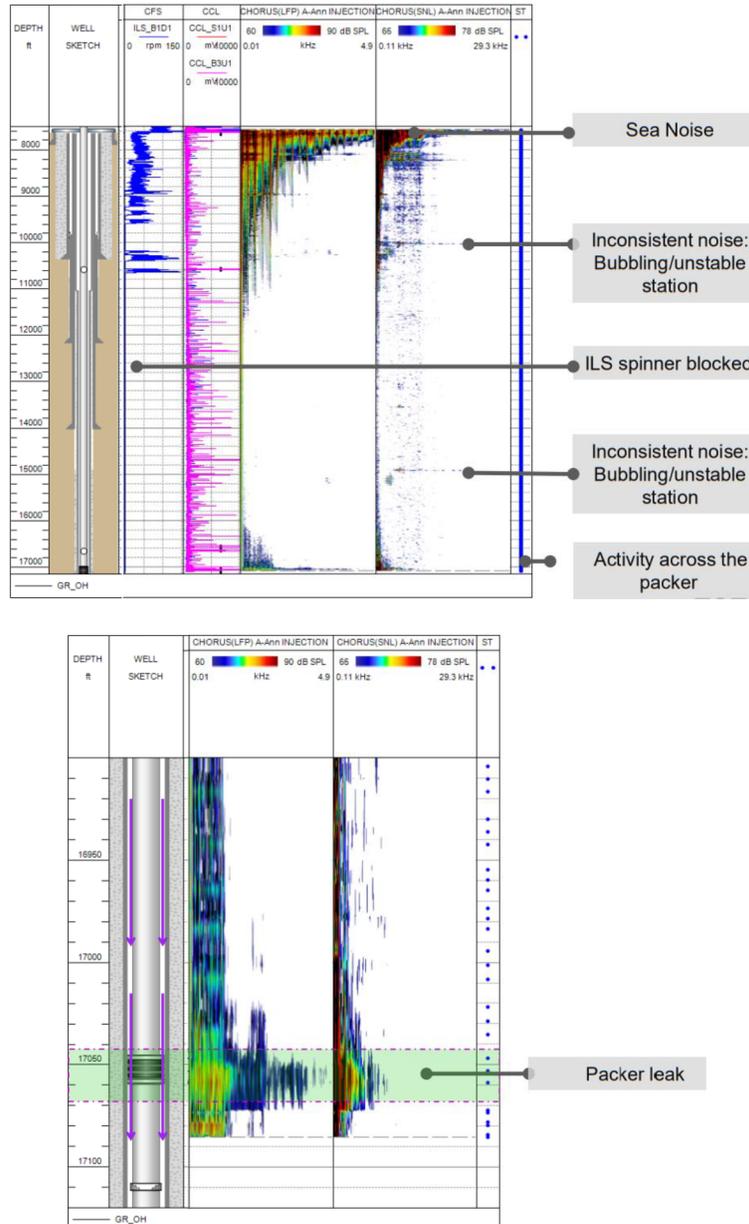
A riser-based intervention to locate the leak point was performed on July 12, 2020. It was determined from the logging data obtained from the acoustic sensing and analysis platform (included in Figure 1 below), that the leak tubing to annulus was located near the production packer instead of the SCSSV, as initially expected. Review of the available data suggested a leak at the production packer, set at 9400 ft MD. This leak location was confirmed through acoustic logging and specified to be caused by a compromised element set.

Figure 2—Acoustic Logging Data Indicating Leakage Across Packer Elements

Considering this information, the operator appropriately shut-in and plugged the well at the gravel pack assembly below the packer. Faced with the prospect of a mechanical intervention, and the associated risks, costs, and non-productive time, the operator elected to perform a riserless intervention to apply pressure-activated sealant to restore integrity to this well.

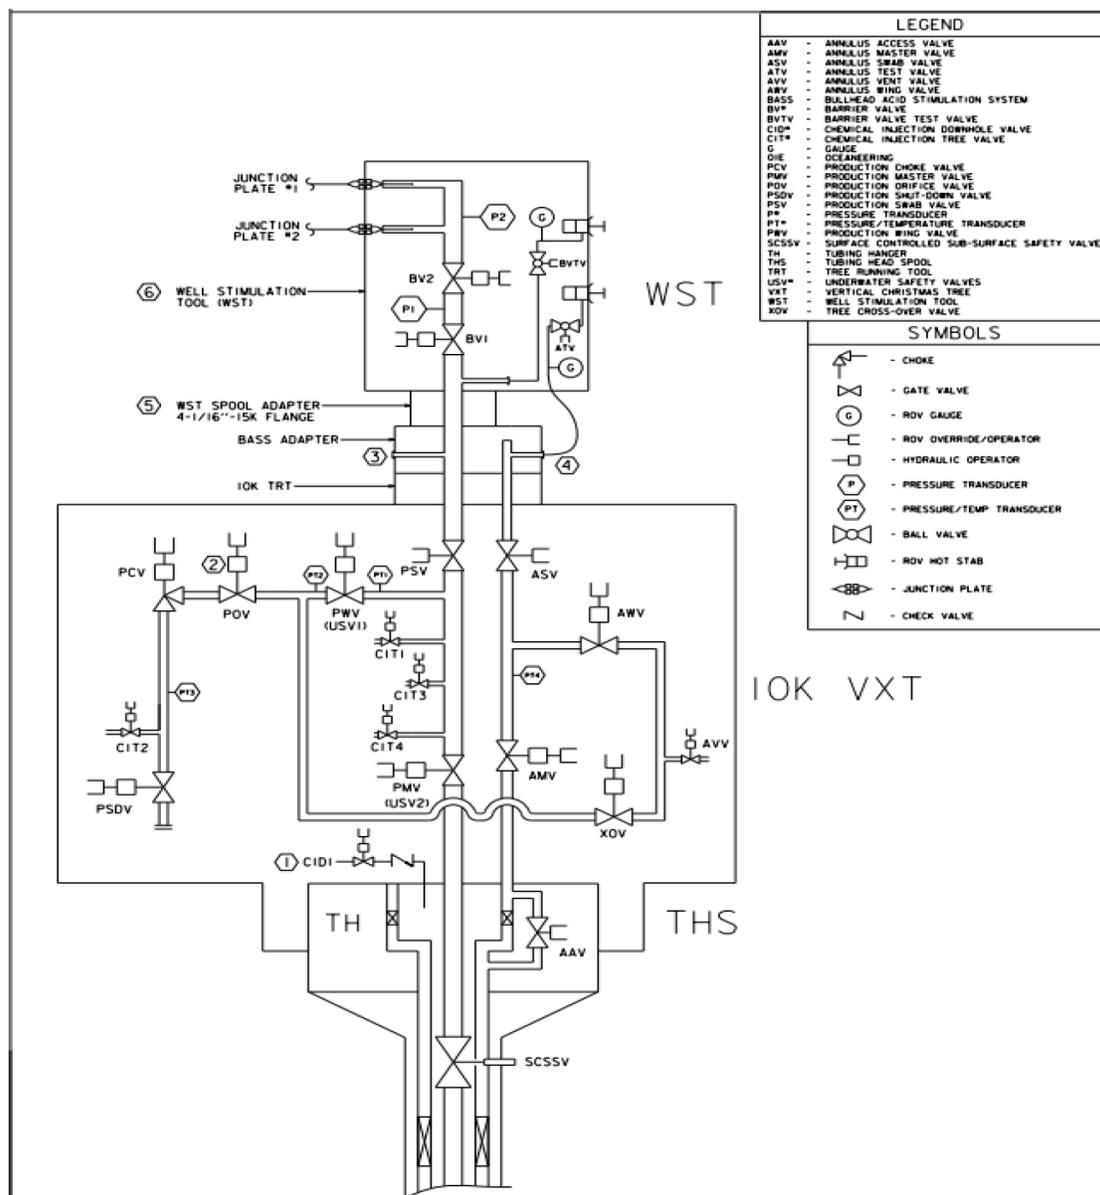
Figure 3—Subsea Sealant Injection Annulus Routing

To confirm and optimize the anticipated sealant injection method, the operator performed SIT testing in conjunction with the sealant and subsea service providers. In the initial planning stages, subsea bladders were selected to be filled on the deck of the vessel, and be deployed to the sea floor. The sealant would then be displaced into the production annulus via a Hydrate Remediation Skid (HRS), or ROV mounted duplex

pump, through a Subsea Safety Module (SSM), composed of a Well Stimulation Tool, Bass Adapter, and Tree Running Tool (Routing pictured in Figure 3 Below). Coiled Tubing was considered to relay the sealant directly to the well or to fill a subsea accumulator system, but ultimately the use of bladders and subsea injection schemes proved to be a better fit for this application.

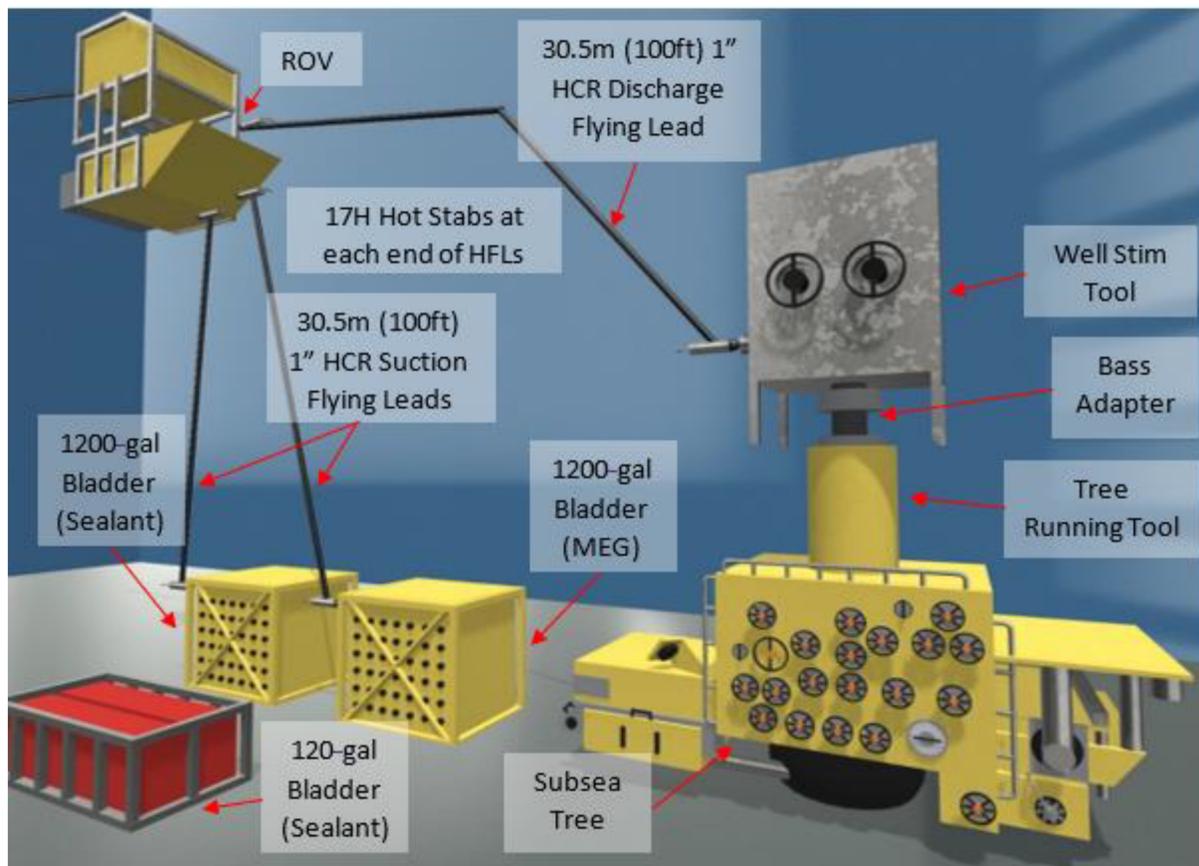
Figure 4—Subsea Injection System Rendering

At the conclusion of the testing, the subsea injection system was then put in place. Two of the selected 1200 gal (4542 L, 28.6 bbl) bladders were filled with an initial 7.5 bbl (315 gal, 1192 L) of sealant and MEG, respectively, and overboarded to be spotted near the well in the safe work zone. Additionally, a 2.9 bbl (120 gal, 454 L) bladder basket was filled with sealant and sent over to provide contingency volume. To facilitate fluid transfer, three, 30.5m (100 ft) hydraulic flying leads were rigged up with 17H hot stabs on either end. A drawing of the injection system is included in Figure 4 below.

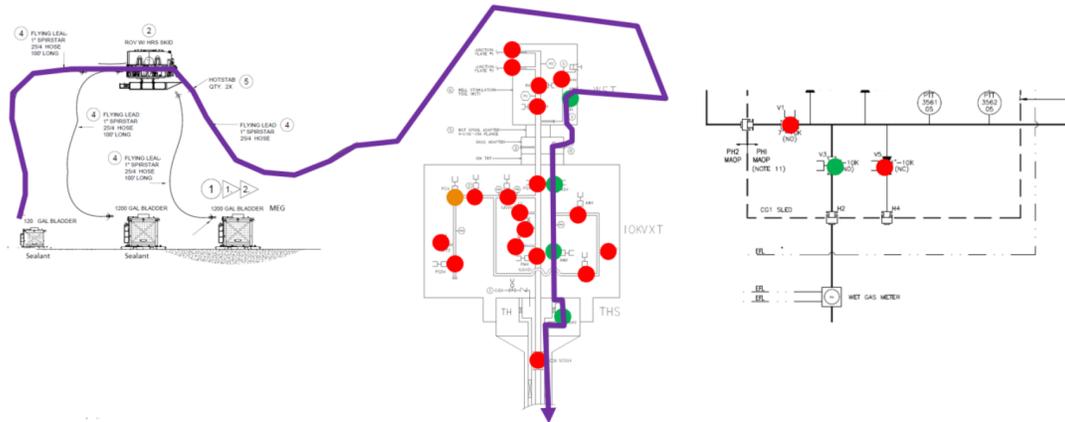
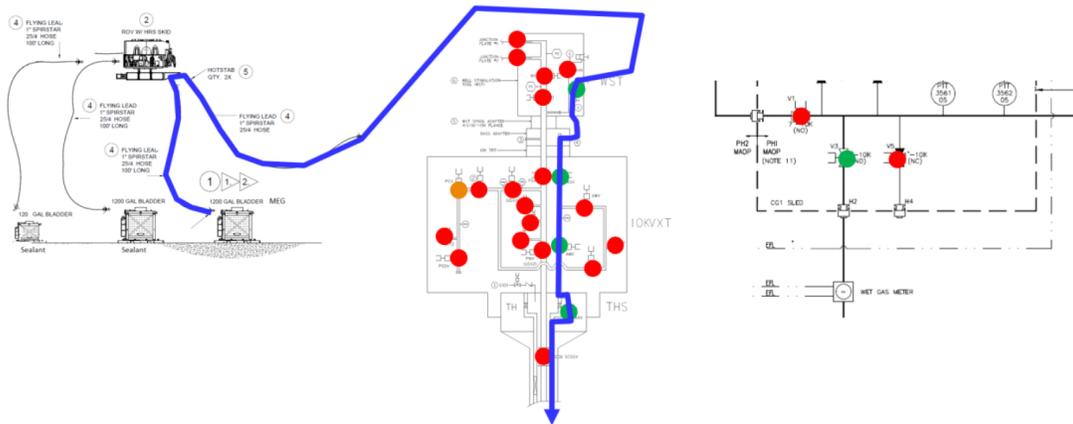
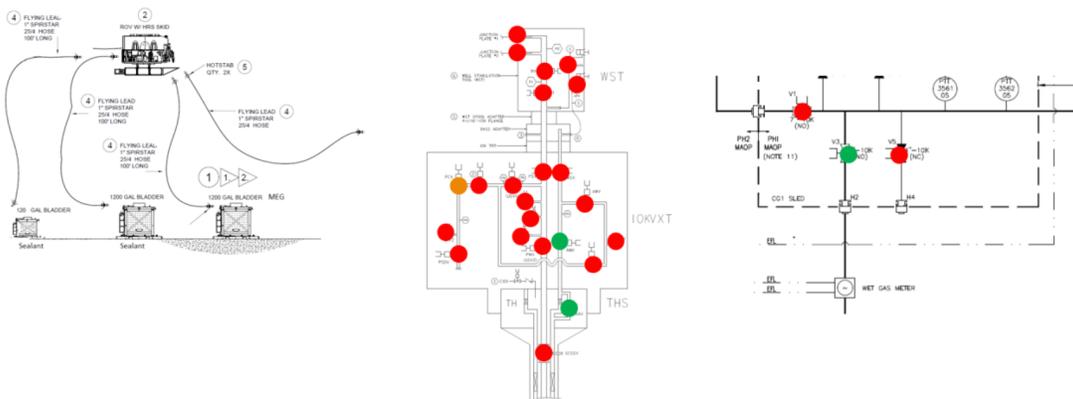
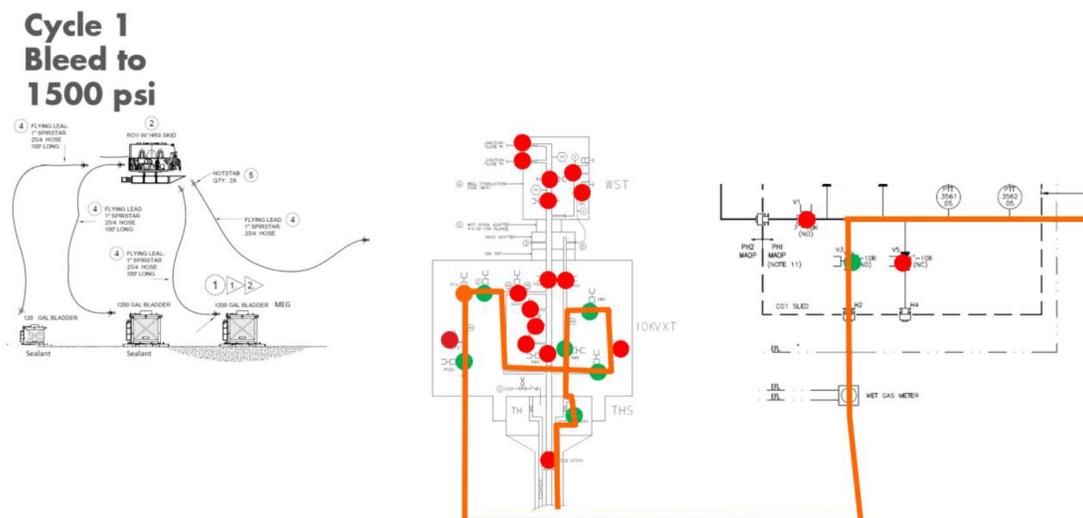
Figure 5—Lube and Bleed Cycle Valve Manipulations and Injection Path

Because this annulus was completely fluid-packed, in order to inject the sealant, four lube and bleed cycles were performed whereby sealant was injected to pressurize the annulus to a determined upper threshold. Once reaching target pressure, the injection was shut-off and time was allowed for the sealant to

fall through the completion fluid. This waiting period was designed to ensure that little to no sealant volume would be lost during the subsequent bleed cycle. After this waiting period, annular fluid was then bled off through the Crossover Valve (XOV) via the flowline to the host platform. A pictorial representation of the process is included in Figure 5 below.

The first of these lube and bleed cycles pulled sealant from the 120 gallon bladders and was only able to increase annulus pressure to equalize with the 3380 psi hydrostatic pressure at the mudline. It was later determined that the flying lead within subsea basket had been unable to be emptied due to a collapsed internal suction line within the bladder. This first cycle had injected approximately 1.2 bbls. For the next two cycles, suction was switched to the larger 1200 gallon bladder and pressure was able to be increased from 1500 psi to 6100 psi. Cycles 2 and 3 both injected roughly 3.5 bbls each. After the third cycle, the 1200 gallon bladder was recovered to deck and re-filled with the remaining 5.5 bbls of sealant available and was overboarded once again. For the fourth and final cycle, pumping from the 1200 gallon bladder, annulus pressure was increased from 1500 psi to 6300 psi, translating to 3.7 bbls of added volume.

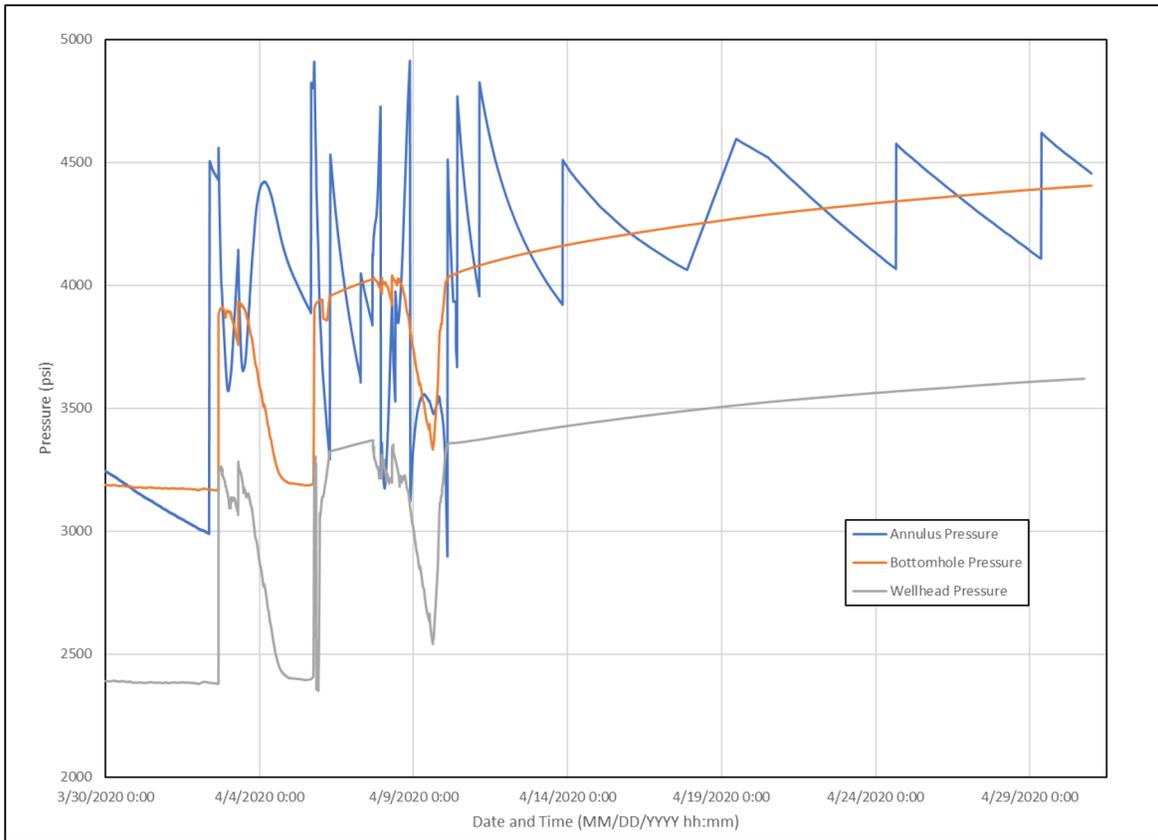
Figure 6—Annulus Pressure Trend Prior to Treatment (April)

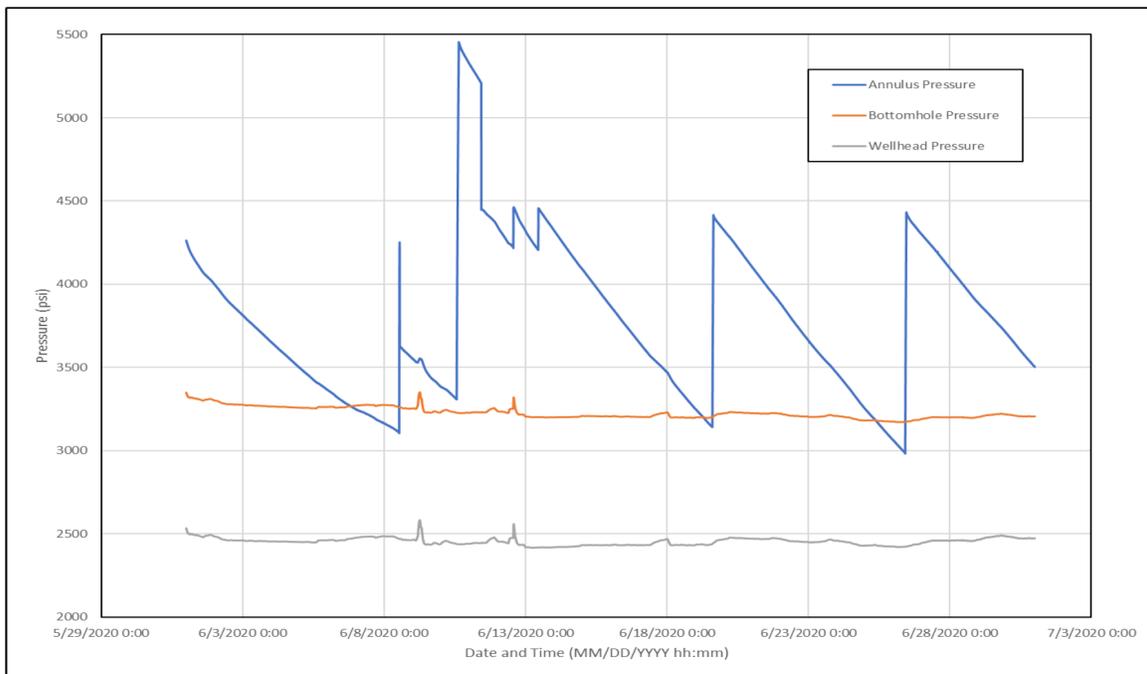
Figure 7—Annulus Pressure Trend Pre-Treatment (June)

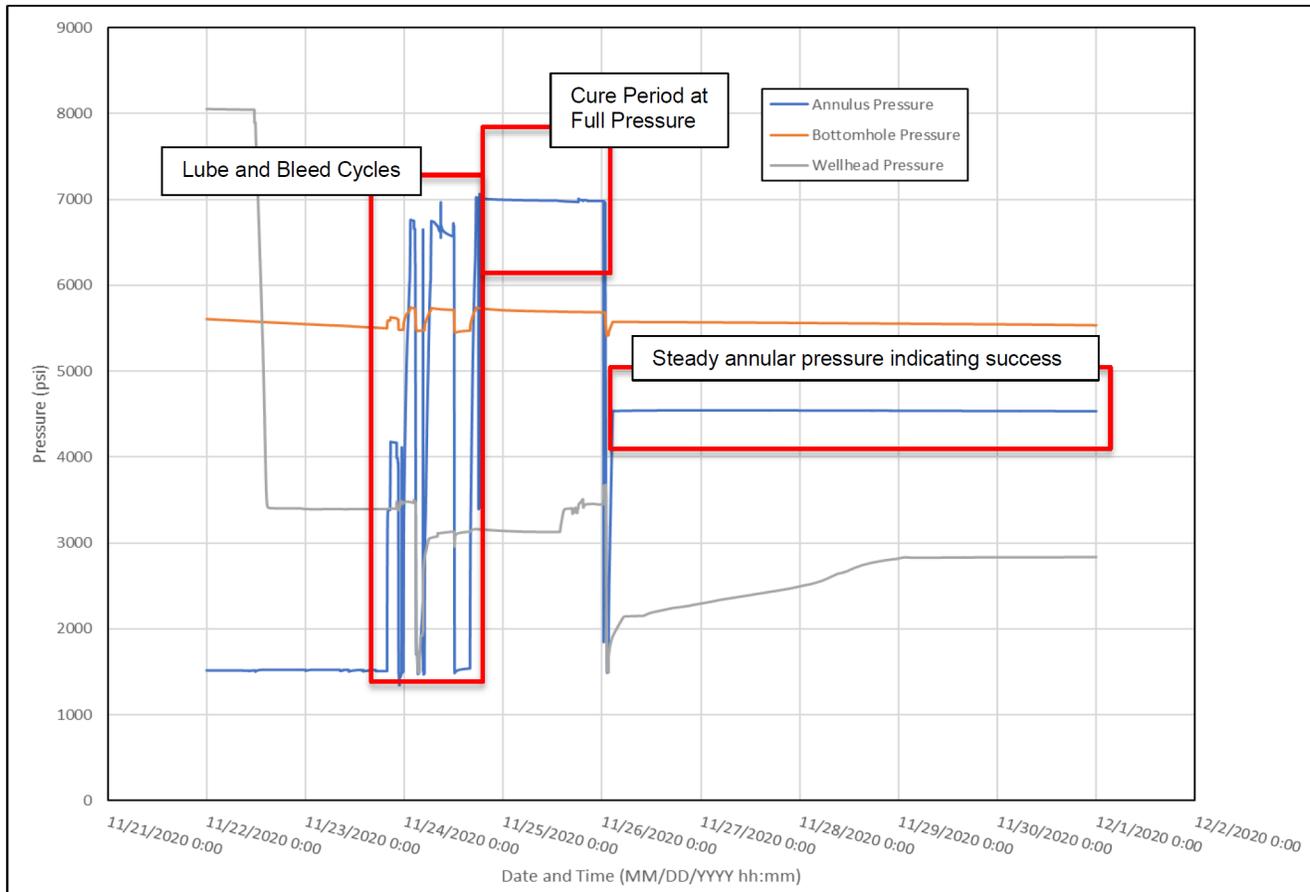
Annulus pressure had stabilized after just over a day after the conclusion of the last cycle and 51 hours after sealant was first injected into the annulus. Pre-Treatment annular pressure trends can be seen below in Figures 6 and 7. Given the observed pressure at the mudline post-treatment and reservoir pressure below, an approximately 5500 psi differential from above was supported by the polymerized sealant and confirmed that the created seal could withstand the annular pressure conditions anticipated for the remainder of the productive life of the well. Following the cure and seeing integrity restored, the operator used the steady post cure-trend as indicated below in Figure 8 as a test demonstrating integrity for the well to be returned to production, now with all critical barriers intact. Figure 8 also illustrates the lube and bleed cycles performed as well as the cure period at full treatment pressure prior to the final test at normal operational pressure.

Figure 8—Annulus Pressure Trend During and After Sealant Treatment (November)
