SPE 108195

Locating and Repairing Casing Leaks with Tubing in Place - Ultrasonic Logging and Pressure-Activated Sealant Methods

J.E. Johns/TecWel: D.N. Cary/Seal-Tite International: J.C. Dethlefs/ConocoPhillips: B.C. Ellis/Seal-Tite International: M.L. McConnell/ConocoPhillips: G.L. Schwartz/ConocoPhillips

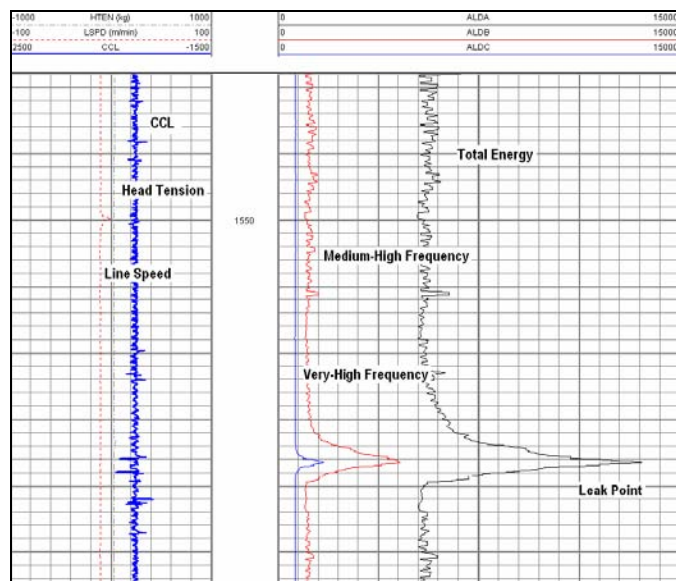
The graphical representation of the tool response shows three frequency windows of investigation (**Fig. 1**). Three traces used are the total energy level, a medium-high frequency range, and a very high frequency range (ALD A, B and C, traces respectively). These are unitless measurements of signal strength. A casing collar locator (CCL) is also presented for correlation purposes.

The leak signature shown in Figure 1 is a tubing leak in a water injection well with a magnitude of approximately 0.08

gpm with a differential pressure across the leak of 900-1200 psi.

Figure 1: Graphical representing the tool response of the ultrasonic leak detection tool. This illustration demonstrates the frequency response of the tool as it is passed by a leak at typical logging speeds.

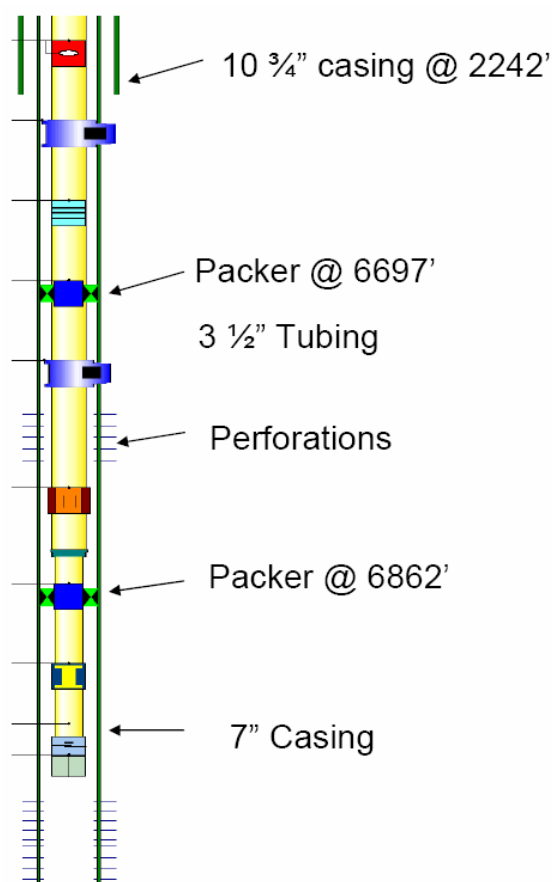
Figure 2: Schematic of Well A.

Ultrasonic Leak Detection. Well A (**Fig. 2**) is an active water and gas injection well completed with 3.5" tubing inside 7" casing. The "A" annulus failed a mechanical integrity test and was shut in due to loss of a barrier.

Pressure Activated Sealant Deployment. Once the location and characteristics of the leak location was identified, repair options could be reviewed. Within the history of pressure activated sealants, thread leaks typically have a much higher chance of long term success than leaks caused by corrosion (high surface area, low cross-sectional area). Therefore the knowledge that the leak was most likely in a casing collar increased the confidence level in a pressure activated sealant repair.

To perform the repair, a water based sealant weighing approximately 8.5 ppg was selected. In order to accurately place the sealant across leak, a delivery “platform” was created using brine heavier than the sealant, approximately 9.6 ppg. A plug was set in the tubing below a gas lift mandrel at 6665’ and the gas lift dummy was pulled to expose a circulation path between the tubing and annulus. The 9.6 ppg brine was then circulated until the annular fluids were fully displaced with brine.

A 3 bbl pill of 8.5 ppg pressure activated sealant was injected into the annulus (equivalent to approximately 120’ in 7” x 3 1/2” annulus). The sealant was displaced to the leak site down the annulus using 80 bbls of diesel (6.8 ppg) while returns were taken from the tubing. The bottom of the sealant was spotted at approximately 2550’, 24 feet above the leak site. Tubing returns were closed and additional diesel was pumped into the annulus in order to increase the squeeze pressure to 3000 psi. Annulus brine was squeezed through the leak until the sealant arrived at the leak site and started the activation process.

Over the space of 18 hours the pressure drop through the leak decreased from 130 psi/hour to 30 psi/hour. At that point the gas lift dummy was reinstalled and the well was returned to active water injection. The well subsequently passed a 2800 psi Annular Mechanical Integrity Test (MIT), with no pressure bleed off noted over 24 hours. The annular pressure was then reduced to 800 psi and the well returned to normal water injection service.

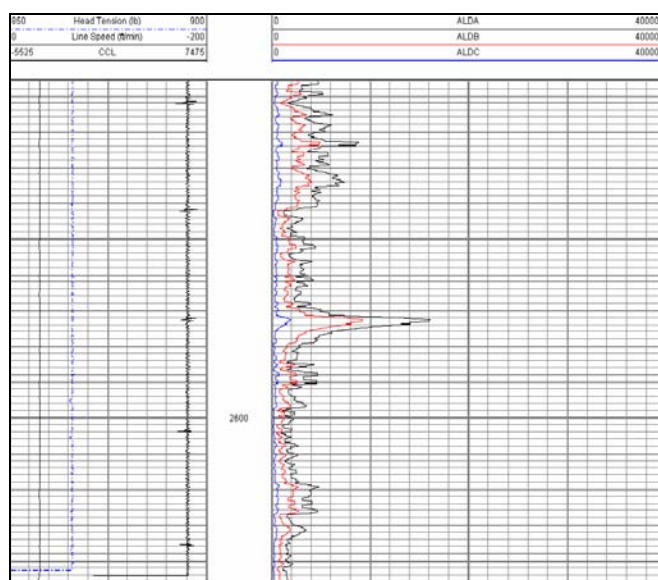
During logging operations, a mechanical integrity test was emulated by maintaining the "A" annulus pressure between 3300 and 2800 psi. A calculated leak rate was established between 0.21 and 0.39 gpm. A typical leak signature was located at 2574' measured depth (MD) during a dynamic pass of 30 ft/min, (**Fig. 3**).

Upon further analysis of other well data available, it was determined that the leak signature was in close proximity with a casing collar behind the tubing. The ultrasonic log results, combined with historic data, created a clear picture of the leak location and probable damage mechanism.

Figure 3: Well A Dynamic log showing casing leak at 2574' measured depth.

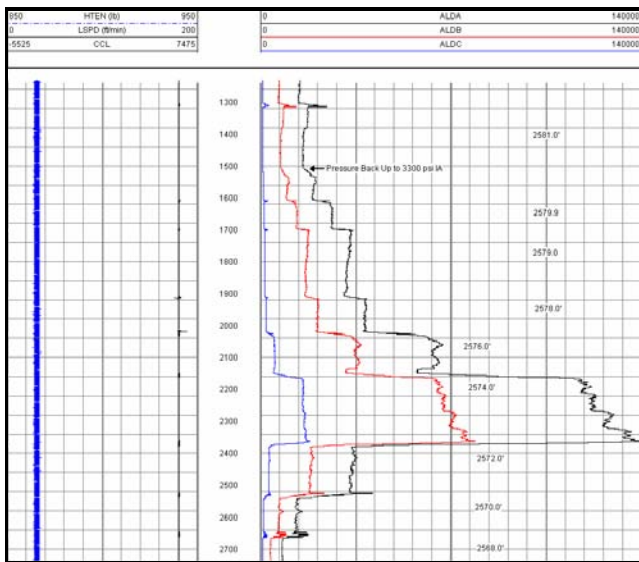
In order to further confirm the leak location, stationary readings are taken through an interval above and below the leak point (**Fig. 4**). The center scale, as with all stationary logs presented, has units of time in seconds. The depths are annotated. The tool was positioned at 2' intervals above and below the leak to verify the leak location. Note the change in signal strength over these intervals demonstrating the resolution of the tool.

Figure 4: Signal response while taking stationary logs on Well A. Maximum signal strength is shown at 2574'.

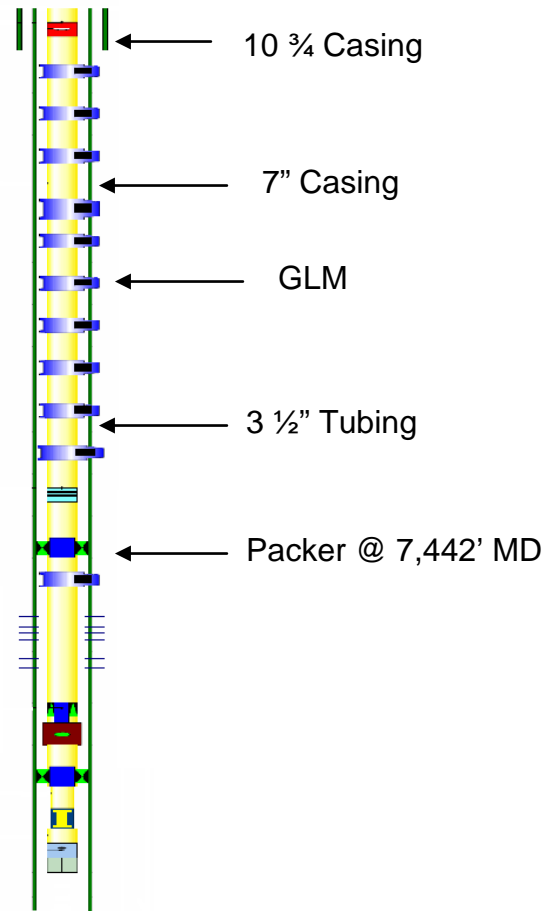
Figure 6: Schematic of Well B.

Ultrasonic Leak Detection. Well B (Fig. 6) is also an active injection well completed with 3.5” tubing inside 7” casing. The well was initially restricted from MI service and then shut-in due to a loss of barrier indicated from a failed Mechanical Integrity Test.

A correlation of the leak depth with the casing tally indicated that the leak was in proximity to a landing collar installed in the casing string. After location and analysis of

Pressure Activated Sealant Deployment. As mentioned in the previous case history, an accurate knowledge of the leak location and characteristics provided confidence in the selection of pressure activated sealants as the best repair option. A similar procedure as the previous example was employed. A 3 bbl pill of 8.5 ppg pressure activated sealant was “floated” on 9.6 ppg brine and displaced to the leak location with 70 bbls of diesel. Then 1.8 bbls of diesel was used to pressure the annulus to 3000 psi. The initial annulus pressure drop was 1300 psi in 30 minutes. After 4 hours of maintaining annulus pressure at 3000 psi the sealant reached the leak location and the pressure drop fell to 200 psi in 30 minutes.

After an additional 8 hours of sealant cure time the dummy was replaced in the gas lift mandrel and the annulus pressure reduced to the required test pressure of 2000 psi. The pressure was monitored over the next 24 hours with no bleed off noted, indicating a successful annulus MIT. At this point the annulus pressure was reduced to 800 psi and the well was returned to normal water injection service. The annulus pressure history during the repair is shown in Figure 10.

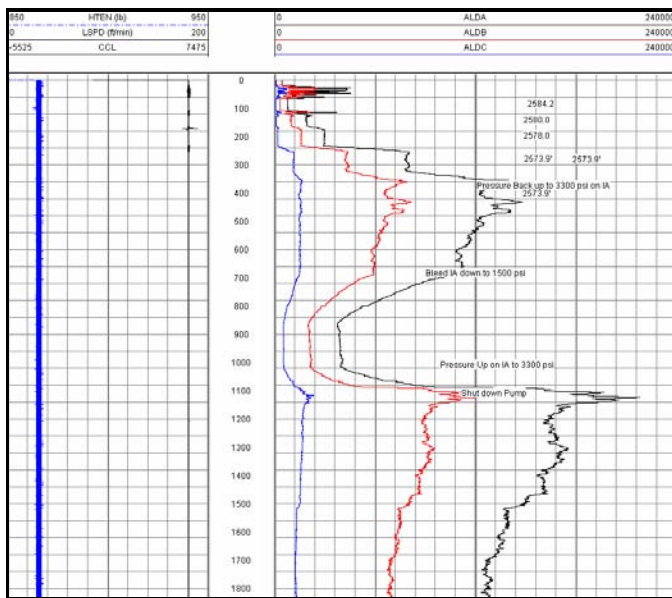
When the tool is placed precisely at the leak point and the annular pressure is manipulated (by bleeding or pressuring up the annulus), the change in signal strength can be observed associated with the leak magnitude (**Fig. 5**). This measurement, along with the tubing and annulus pressure response monitoring, confirm in which barrier the leak is located. As the pressure is decreased in the annulus, it can be seen that the signal strength diminishes. As the pressure is increased, the signal strength increases.

Figure 5: Well A stationary log showing response in signal strength as the pressure is manipulated.

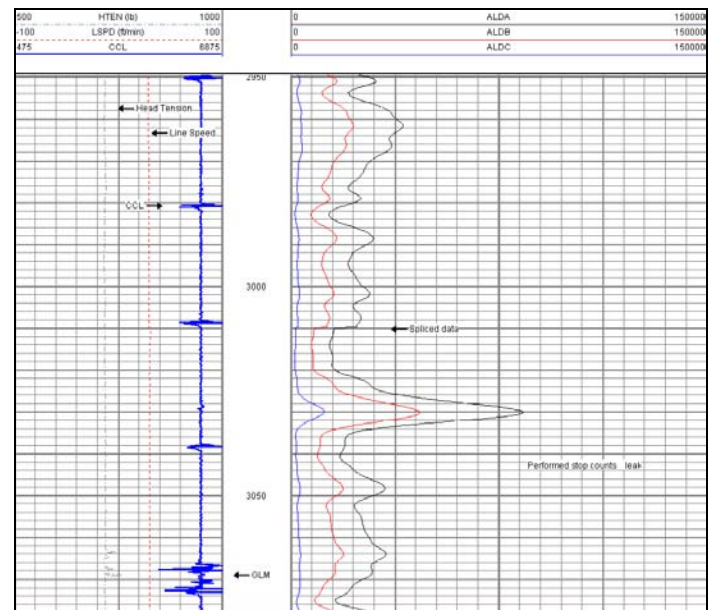
During logging operations, the leak was established by maintaining the “A” annulus pressure between 2500 and 2000 psi. using diesel. The leak rate established ranged from 0.44 and 0.83 gpm. A leak signature was located at 3060’ measured depth (MD) during a dynamic pass of 30 ft/min, (Fig. 7).

Figure 7: Dynamic log of tubing in Well B with leak at 3,030' MD.

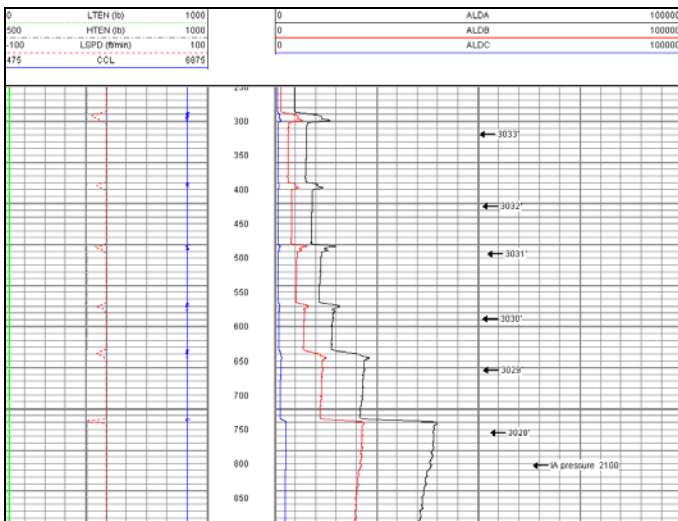
The leak location was confirmed by stationary readings and manipulating the leak rate (Figs. 8 & 9).

Figure 8: Signal response while taking stationary logs on Well B.

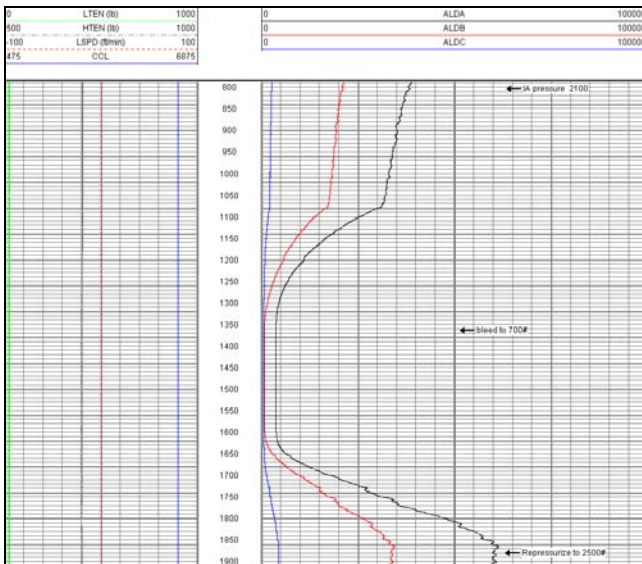
Figure 9: Well B stationary log showing response in signal strength as the pressure is manipulated.

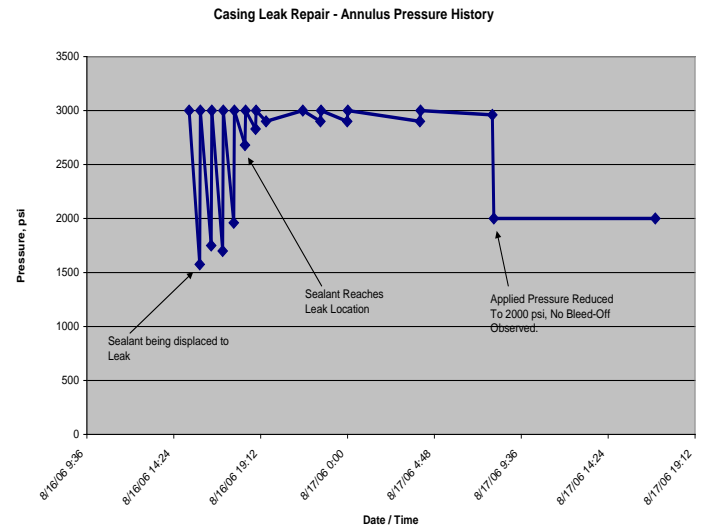
Figure 10: Graph of annulus pressure history during leak repair process.
