**SPE 120978**

## **Pressure Activated Sealant Economically Repairs Casing Leaks on Prudhoe Bay Wells**

R. W. Chivvis\* and J. Y. Julian\*, BP, Inc.; D.N. Cary, Seal-Tite International \*SPE Members

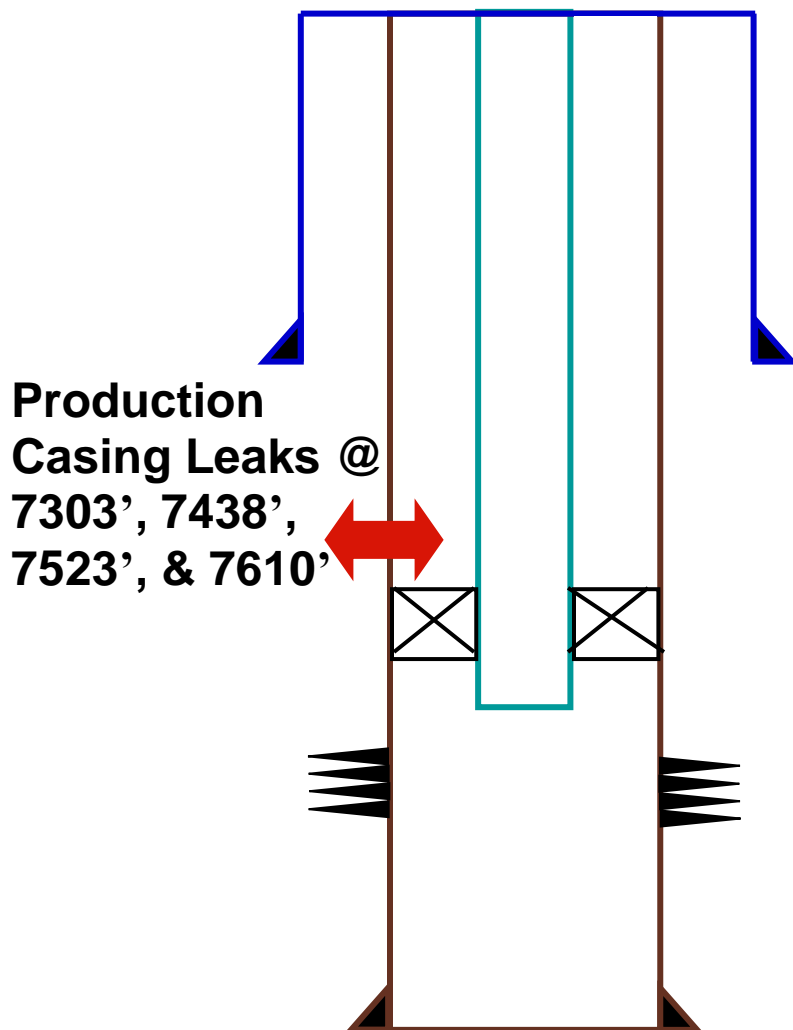
**Figure 2 Wellbore Schematic of Well #1**

Well #1 is a natural flowing producer that had four leaks between 7303' and 7610' MD in the 9 5/8" 47# L-80 casing (Figure 2). This well has a tapered 5 1/2"x 4 1/2" tubing string inside the casing. The first indication of the casing leak was high “A” annulus pressure. The “A” annulus failed a mechanical integrity test (MIT) and the well was shut-in. The Mechanical Integrity Test (MIT) test results indicated a production casing or packer leak.

A procedure was prepared using the well and leak information and the repair process was started. The valve was pulled from the lowest GLM. A wire-line retrievable plug was set in the tubing just below the lowest GLM. Brine that was 0.4 ppg heavier than the sealant was pumped down the tubing and back up the “A” annulus until both were completely filled with brine. Seven barrels of sealant were pumped down the “A” annulus and displaced with diesel. The sealant was carefully displaced down the “A” annulus to the top leak after allowing for the compression of fluids above and below the sealant. The tubing was closed and the “A” annulus pressured up to 3000 psi to force the sealant into the leak and activate the sealant with the pressure drop through the leak. The “A” annulus pressure was maintained at 3000 psi by bumping up the pressure as required when it slowly leaked off. After 12 hours at one leak depth, the sealant slug was displaced to the next lower depth by bleeding off tubing pressure and pumping diesel down the “A” annulus. This process continued until all four leaks were sealed. Then the “A” annulus pressure was reduced to 1500 psi and held for 3 days to allow the sealant to cure. The well passed a mechanical integrity test of the “A” annulus to 3000 psi and was returned to production.

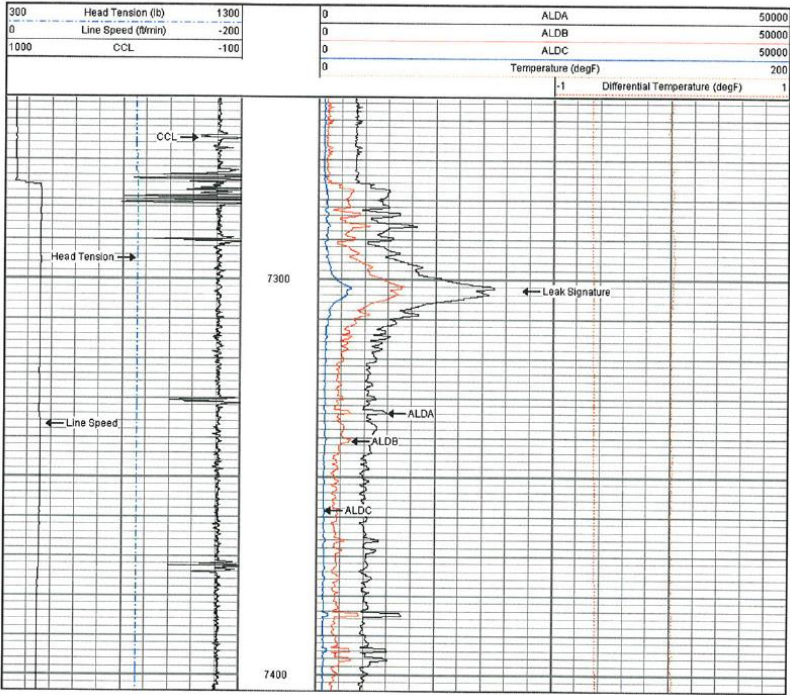
Figure 3 Ultrasonic leak detection log on Well #1

tool was run in the tubing while pumping 0.5 gal/min down the “A” annulus. The ultrasonic log found four small leaks in the 9 5/8” production casing between 7303’ and 7610’ (Figure 3). The ultrasonic log was used because well had a low liquid leak rate and the leak was behind tubing.

4.2 Log –Leak @ 7,303’ MD

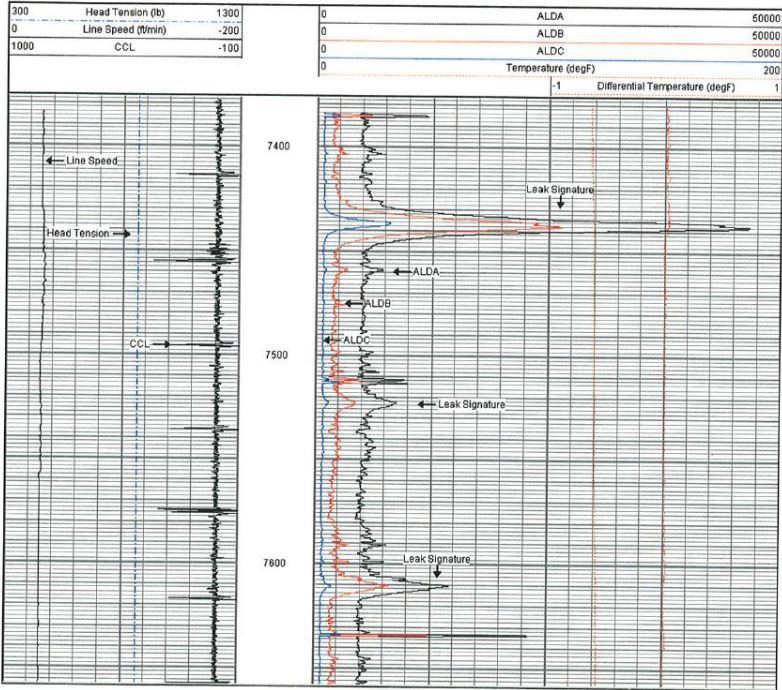
4.1 Log – Leaks @ 7,438’ - 7,523’ and 7,610’ MD.

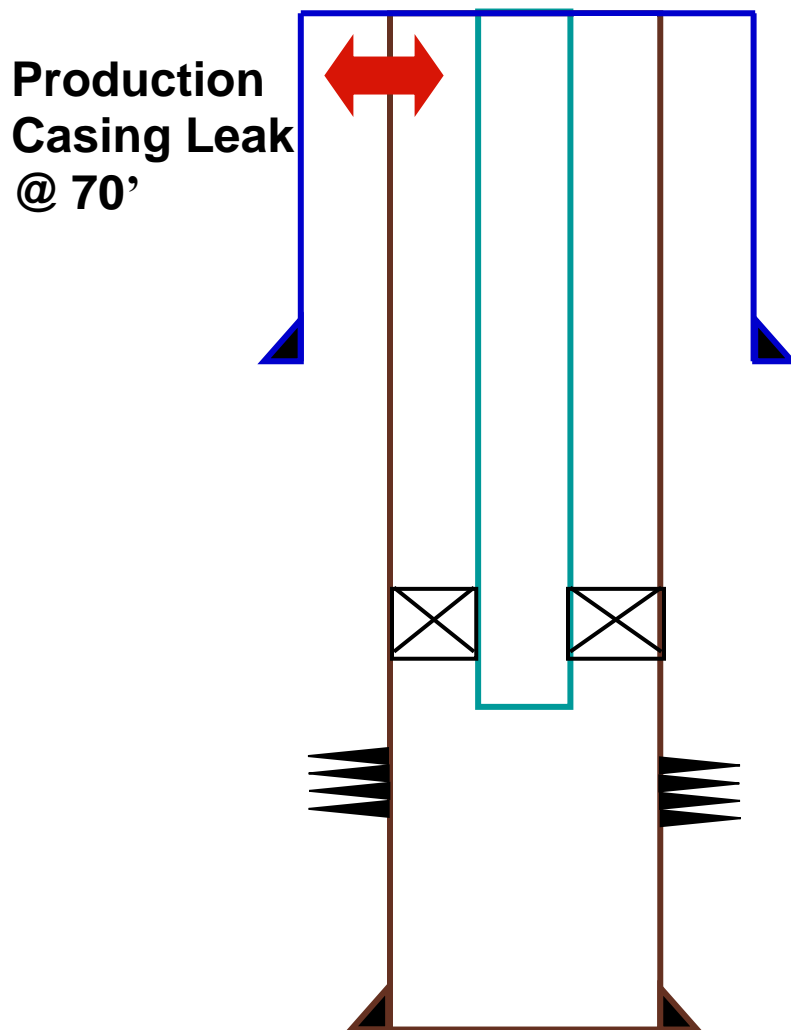
### Figure 4 Wellbore Schematic of Well #2

Well #2 is a natural flowing producer that had a leak at 70’ MD in the 9 5/8” 47# L-80 production casing (Figure 4). The well has a 4 1/2” tubing inside the casing. The first indication of a casing leak was the “A” annulus pressure tracking the “B” annulus pressure. The “A” annulus subsequently failed a MIT which indicated a casing leak.

The casing repair on this well used a similar procedure as the previous example. A plug was set in the tubing tail and a circulation valve was set in the bottom gaslift mandrel. Brine that was 0.4 ppg heavier than the sealant was pumped down the tubing and back up the “A” annulus until both were completely filled with brine. Two barrels of 9.2 ppg sealant were displaced down the “A” annulus to the leak depth with diesel. The “A” annulus was pressured to 1000 psi to force the sealant into the leak. The “B” annulus pressure was bled down and monitored. Once there was no increase in the “B” annulus pressure, the “A” annulus pressure was increased to 2500 psi and held for three days to cure the sealant plug. The “A” annulus passed a mechanical integrity test to 3000 psi and the well was put back on production.

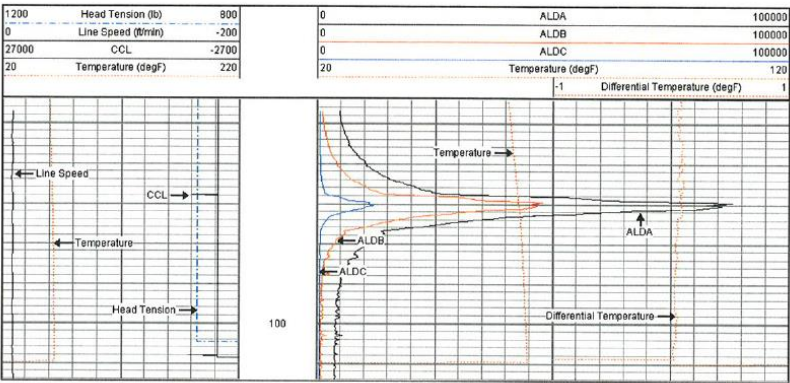
The size, depth, and location of the leak was needed to evaluate repair options and screen the well for a pressure activated sealant repair. A liquid leak rate of 2 gal/min at 1500 psi was calculated from the MIT. An ultrasonic leak detection log was run and found the casing leak at 70’ MD (Figure 5) and measured the leak rate of 1 gal/min over 3 hours. The ultrasonic log was used because the well had a low liquid leak rate and the leak was behind tubing.

4.1 Log – 9 5/8” Casing Leak @ 70’ MD.

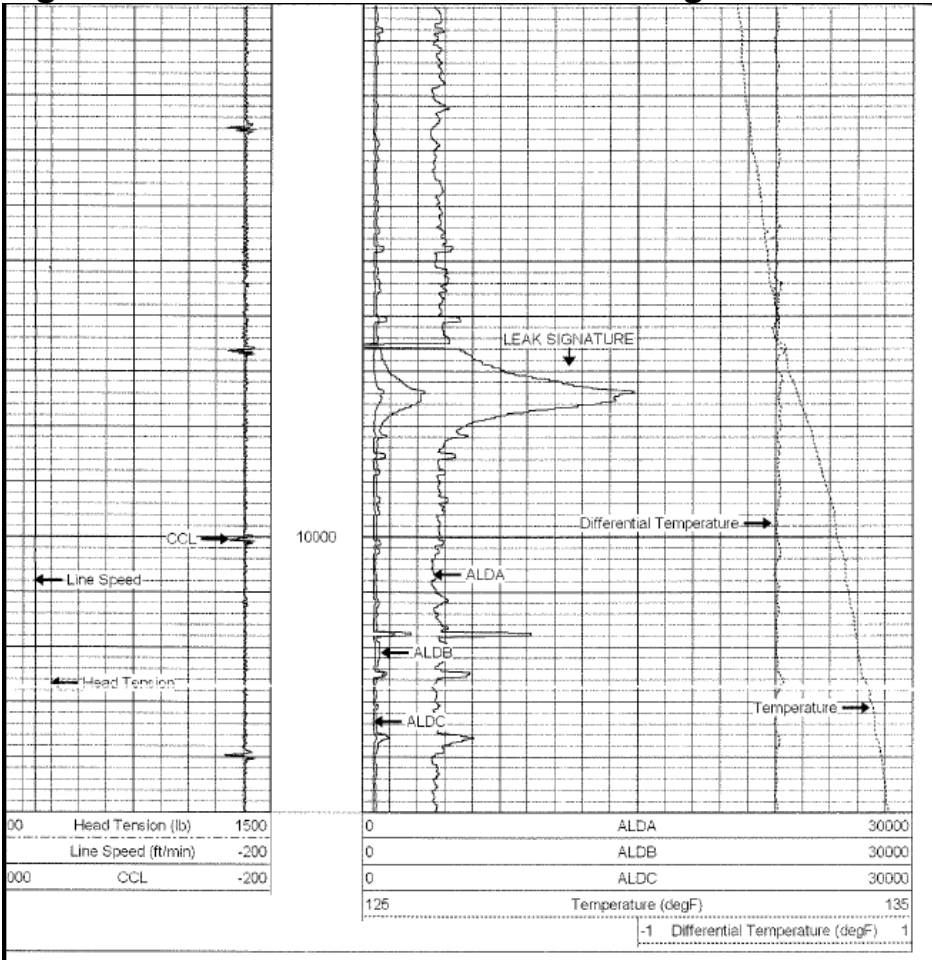
Figure 7 Ultrasonic Leak Detection Log on Well #3

Well #3 is a gas lifted producer that had a leak at 9974’ MD in the 9 5/8” 47# L-80 production casing (Figure 6). The well has a 4 1/2” tubing inside the casing. The first indication of the casing leak was high “A” annulus pressure.

The size, depth, and location of the leak were needed to evaluate repair options and screen the well for a pressure activated sealant repair. A liquid leak rate of about 1 gal/min at 3000 psi was calculated from the MIT. An ultrasonic leak detection log was run and found the casing leak at 9974’ MD (Figure 7) and measured the leak rate of 0.36 gal/min at 3000 psi. The ultrasonic log was used because the well had a low liquid leak rate and the leak was behind tubing.

1. The depth of the leak was known.
2. The liquid leak rate was low, below 1 gal/min.
3. The well had a GLM to circulate fluids down the “A” annulus below the leak depth
4. The well equipment was rated for the pressures expected in the procedure.
5. There were not any “thief” leaks in the system.
6. A positive pressure differential could not be maintained on the sealant plug when the well was returned to service. This well normally operates on gaslift. The pressure in the “A” annulus at the leak was calculated using the hydrostatic head of the gaslift gas and the normal surface operating pressure of the gaslift. This pressure was less than the pressure expected on the other side of the leak. Without being able to maintain a positive pressure differential on the sealant plug there was a low probability of success.

The pressure activated sealant treatment was not performed on this well since it did not satisfy all of the screening criteria.
