SPE-173826-MS

Casing Leak Investigation & Successful Repair by Application of Pressure Activated Liquid Sealant in a Newly Completed Well in Offshore Environment – A Case Study

Alok Kumar Singh, Bhushan Patil, Kunal Kishore, Manu Khanna, Sai Rakesh Varma, Cairn India Ltd., Chris Anderson, Seal-Tite International

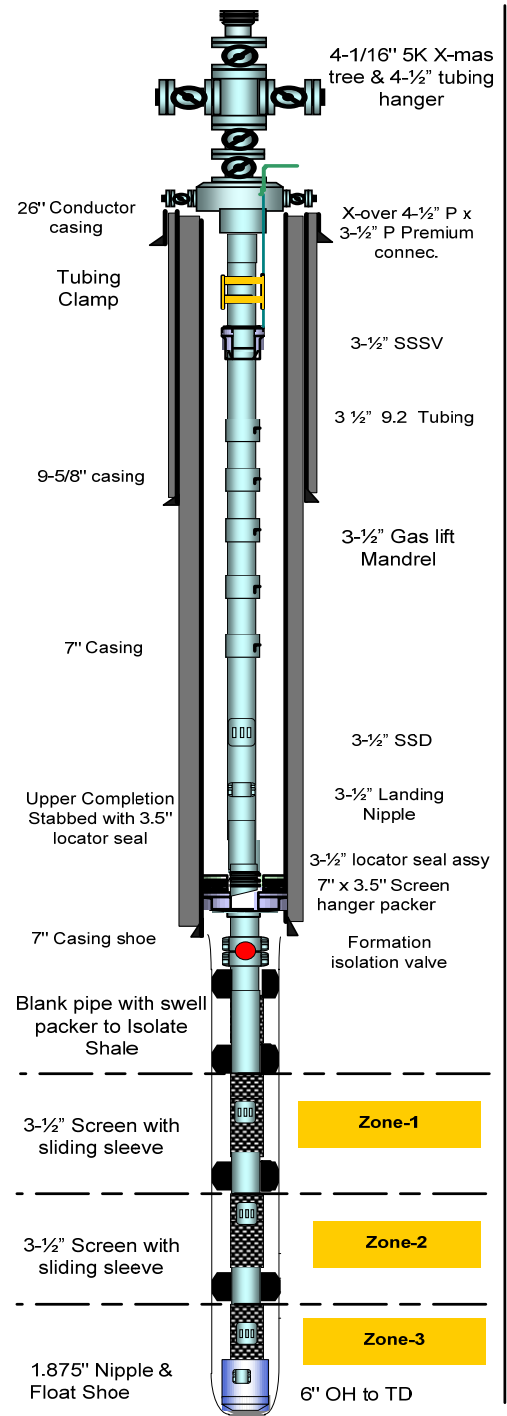
Refer Figure 1 for well construction details. Well was drilled out of 26" conductor casing followed by 9-5/8" surface casing and 7" production casing. It was completed in 6" Open Hole with 3.5" Stand Alone Screens with SSD's. Lower completion comprised of, from bottom to top, Float shoe, Landing Nipple, Screens w/blank pipe and swell packers, Formation Isolation Valve & Screen Hanger packer. Upper completion was 3.5" that comprised of Tie back Seal assembly, Bottom No-Go Landing Nipple, Circulation SSD's, GLM's, TRSSSV & Tubing hanger.

Figure 1: Well Construction

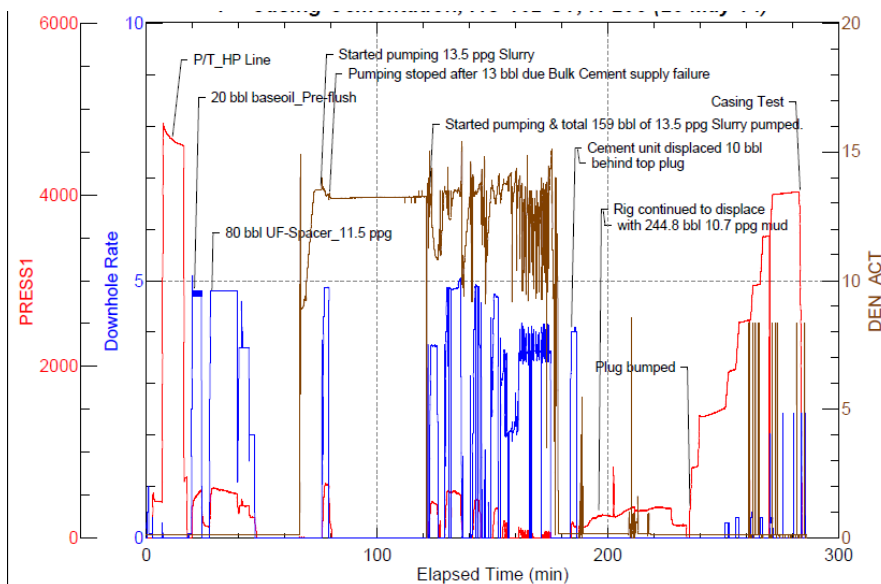
After drilling 8-1/2" hole, 7" production casing was run and cemented. Pressure test of 7" production casing was carried out at 4000 psi as per SOP after cement plug bumping. The pressure test indicated an increasing trend of pressure, probably due to the exothermic nature of cement setting process. Refer Figure 2 for casing pressure test. Though casing leak did exist at that stage also, the pressure test chart was misinterpreted as successful casing pressure test and it was decided to proceed to next step of well completion operations. Lower completion was then run on 3-1/2" drillstring & screen hanger packer was set. Pickup & slack off test of 20k lbs was then successfully conducted. However, pressure test of packer attempted from annulus side failed. The packer running tool was then released & Shifting Tool was pulled through FIV to close it. The well was then displaced with filtered kill weight Packer Fluid.

Figure 2: Pressure test of 7" production casing @4000 psi after cement plug bumping

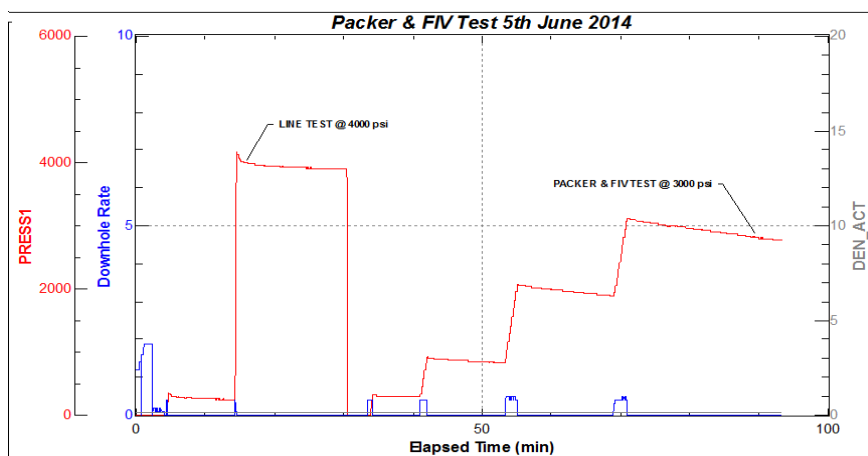
The packer & FIV were again pressure tested against Production casing by closing Blind ram at different pressures of 300, 900, 2000 & 3000 psi in stages. Average pressure drops in the range of 1.5 psi/min, 6 psi/min, 11 psi/min & 15 psi/min were observed at respective pressures. B-Annulus (7" X 9 5/8") was monitored for returns – Observed continuous returns. Further, the returns stopped as soon as the pressure was bled off. The above investigation was repeated with same results. Please refer to Figure 3 for pressure test chart for the above event.

Figure 3: Leak observed while testing Packer & FIV

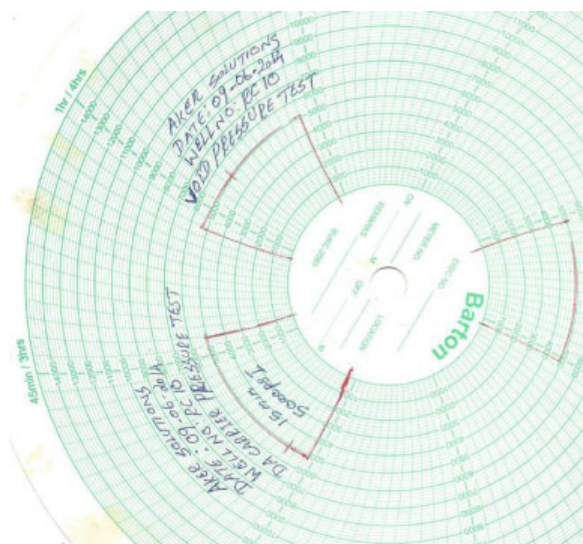
7" Casing hanger pack-off seals was successfully tested to 5000 psi and this eliminated any possibility of hanger being the leak path. Refer Figure 4 for integrity test of the casing hanger seals. Being newly drilled, any damage in the 7" casing pipe body was highly unlikely. CBL-VDL-USIT log was then

Figure 4: Integrity test of 7" casing hanger pack-off.

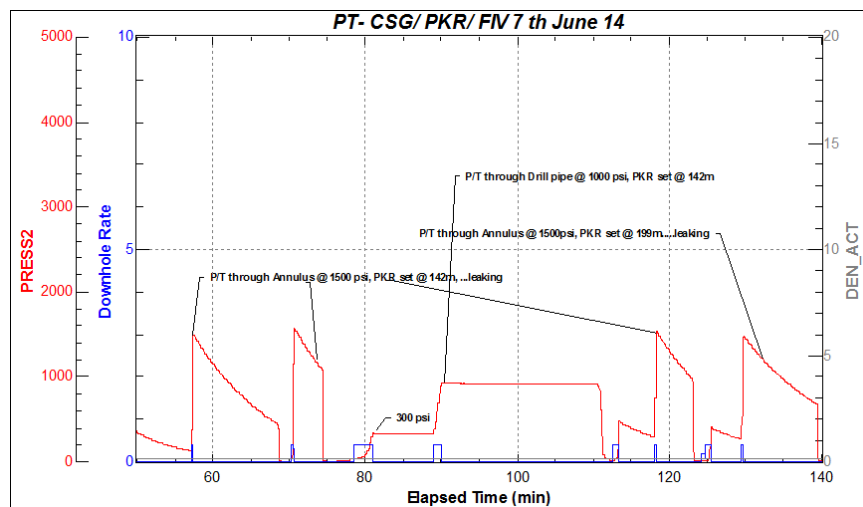
To further investigate the leak depth, a drillpipe conveyed single run multiple set mechanical packer was run. Surface lines were made up to test both from annulus side and drillstring side. Packer assembly was run on drillpipe & packer was set @ 142m for shallow test. Pipe ram was then closed & 3.5" DP X 7" casing annulus was pressure tested, that failed. No pressure response in drillstring was observed. Further, continuous return from B-annulus was also observed. The above was repeated with same result.

Figure 5a: Pressure test with packer set @ 142m

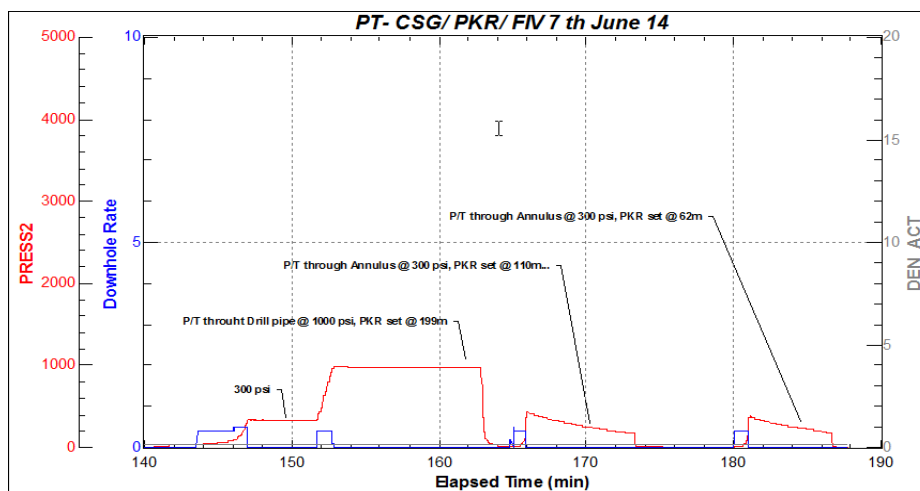
Pressure test was then conducted from drillstring side, which was successful. Further, no returns from flowline & no return from B-annulus were observed. The above indicated a shallow depth casing leak. To pin-point the exact leak depth, the above event was repeated at following depths – 199m, 110m, 62m, 31m, 20m, 21m & 22m. It was finally established that the bottom connection of Cross over below 7" casing hanger pup joint @ 21.9mMDBRT was leaking. Please refer to Figure 5a, 5b, 5c & 5d for pressure test charts attached for the above mentioned sequence of events.

Figure 5b: Pressure test with packer set @ 199m, 110m & 62m

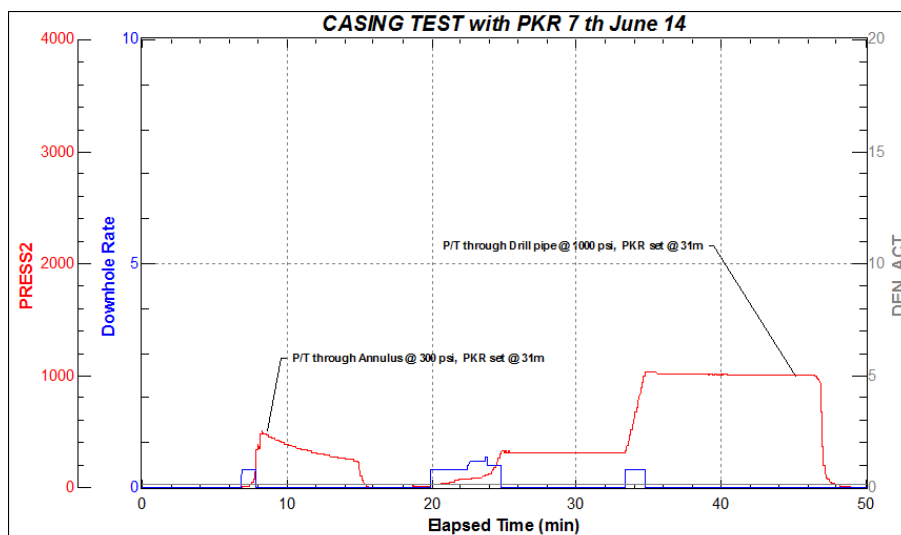
Figure 5c: Pressure test with packer set @ 31m

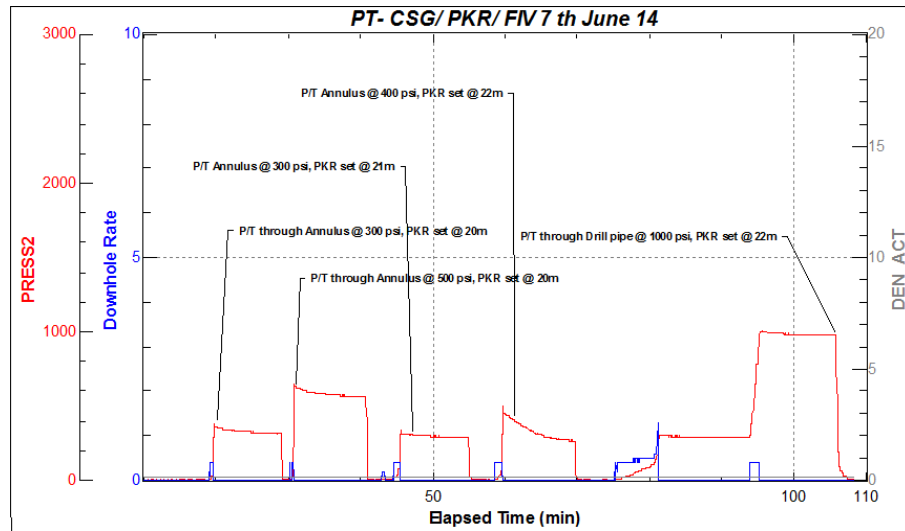
Leak was established at the bottom connection of Cross over below 7" casing hanger pup joint @

21.9mMDBRT. The leak point was 2.9 m below the casing hanger landing point. Diagnostics had indicated a leak rate of ~1 liter per minute which was well within the range of desired leak rates for successful repair job. Diagnostics were verified before pumping sealant. Cementing line was made up from Cement pump to A-annulus. B-annulus was kept topped up with sea water and opened to a catch tank. Refer Figure 6 for the surface set up made for job execution.

Figure 5d: Pressure test with packer set @ 20m, 21m & 22m

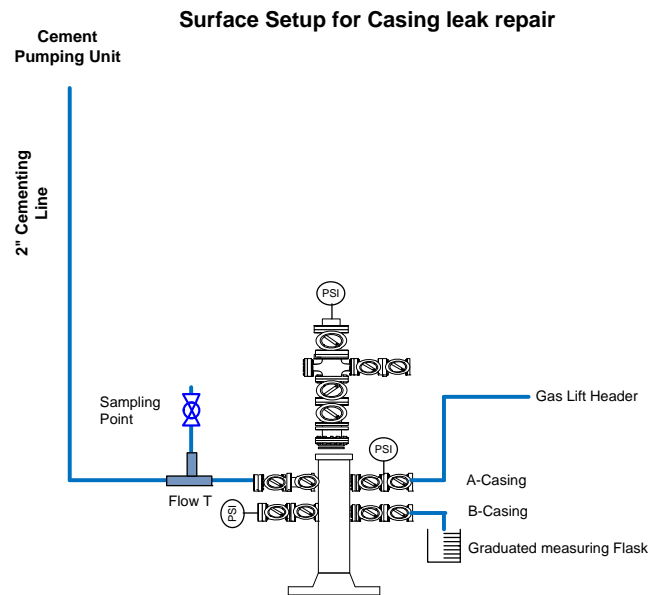
Figure 6: Surface setup for casing leak repair treatment.

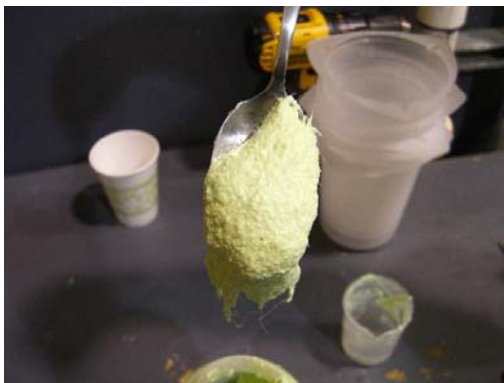
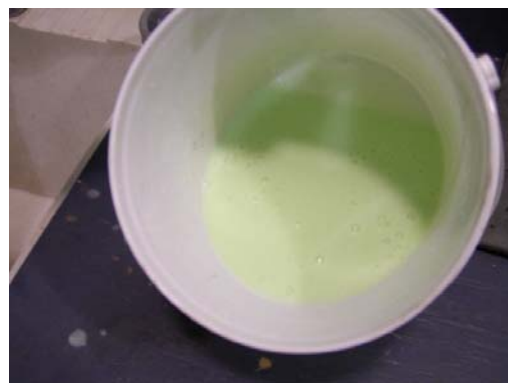
Figure 7: Sealant concentrate before blended with seawater (left) and the blended product (right)

Since the leak was only 2.9 m below the casing valve, the A-annulus fluid compressibility was used to enable placement and controlled squeeze of the sealant pill. Compressibility of annular volume of packer fluid at 1000 psi was 0.52 bbls (7m equivalent) & at 2600 psi was 1.36 bbls (17m equivalent). A 9.1 ppg pressure-activated sealant pill was designed to float on top of the 10.1 ppg packer fluid in the A-annulus. A 3 bbls sealant pill was blended in a cement slurry tank. Please refer to Figure 7 for the picture of sealant before & after blending.

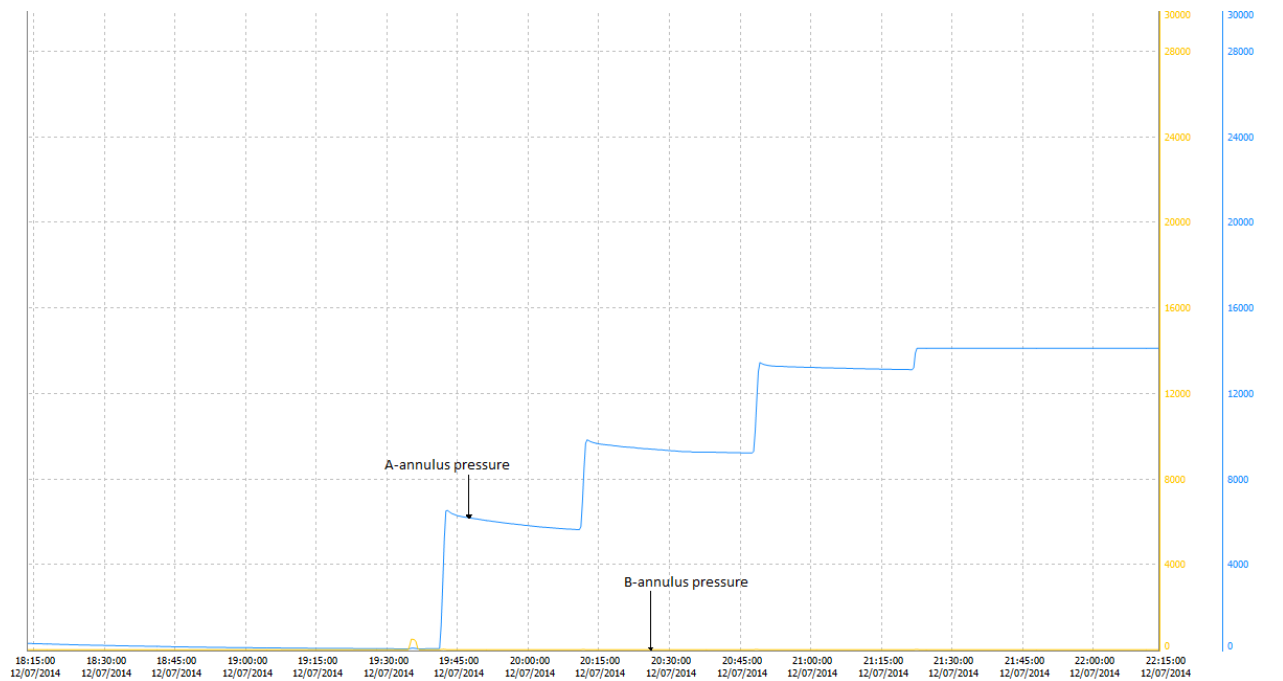
Figure 8. No pressure drop in A-annulus and No pressure build up in B-annulus was observed.

Figure 8: Sealant Placement & curing in pressure steps of 1000 psi till 2600 psi

It is recommended to use a triplex pump with a minimum 3" plunger size. The sealant was then pumped using the triplex pump at minimal rate till sealant was spotted at the flow-tee installed just upstream of A-annulus valve. This was done to ensure that line volume doesn't affect compressibility based sealant spotting calculations. Sealant was chased with packer fluid. The sealant pill was then injected into the A-annulus until the leading edge of the sealant contacted the leak location. During sealant displacement the B-Annulus returns were closely monitored to evaluate sealant progress. The A-annulus was pressurized to 1000 psi to activate the sealant in the leak site. The sealant when squeezed through the leak site converts into a ~90 durometer elastomer through polymerization. The sealant is unique in that it only activates when subjected to the shearing action of a significant pressure differential. The end result is something similar to blood coagulating in a cut. The sealant activated instantaneously at the applied pressure differential. At the same time returns through B-Annulus ceased indicating sealant activation. The seal was allowed to cure at 1000 psi pressure for 30 minutes.

The A-annulus pressure was increased at intervals of 500 psi every 30 minutes until 2600 psi (A-annulus test pressure) was reached. Refer Figure 7 for the pressure trend while sealant placement and curing. The sealant is designed to break at its weakest point as pressure differential is increased. New sealant that is squeezed through this breakage activates becoming a stronger elastomer bond in the leak site. The sealant was allowed to cure with an A-annulus pressure around 2000 psi for 3.5 days. This cure period allows the sealant to increase in durometer but remaining a flexible solid in the leak site. Tubing, A and B Annulus pressures were continuously monitored during the entire duration of the curing time. Refer

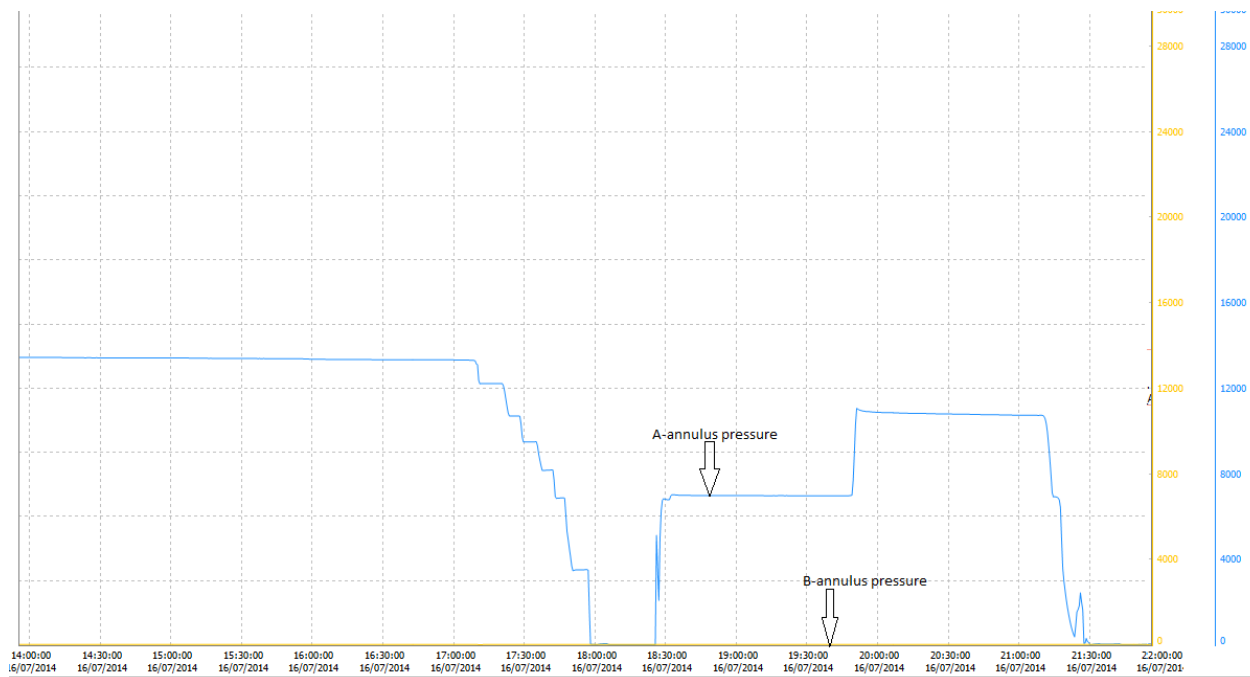
Figure 9: Pressure bled off after completion of curing time & subsequent Seal test with gas at 1000 psi & 1600 psi

The pressure was then gradually bled down back into the cementing line to zero in stages of 200 psi. Bleeding pressure back into the cementing line ensured that residual amount of sealant remained in the cementing line that will be utilized to be pumped during seal test with gas.

This well was designed to be operated on gas-lift in the future requiring a gas test at 1600 psi. Available gas injection pressure at platform (~1000 psi) was applied into A-annulus. The pressure test was successful with no leak from B-casing. Keeping the gas pressure trapped, sealant was pumped through the cementing line to further compress the gas & build up the pressure to 1600 psi. The pressure of 1600 psi was then locked in A-Annulus and monitored for 1 hr. Compressibility calculations done suggest the gas-liquid contact at 7m & 4.6m at 1000psi & 1600 psi respectively in A-annulus, both deeper than the repaired leak depth at 2.9m. Thus, the liquid level remained below the leak location and repaired area remained exposed to 1000 psi & 1600 psi gas pressure. After 1 hour successful test was obtained the A-annulus was bled to zero. Refer Figure 9 containing the pressure chart for the above mentioned event. Sealant was then circulated out of the well through forward circulation by pumping base oil down the tubing till SSD depth & production screens SSD's were opened in preparation for a return to normal production.
