SPE-212925-MS

Subsea Well Annular Integrity Repair Using Coiled Tubing and Pressure Activated Sealant

Joel E. Johns and Chris Anderson, Seal-Tite International; Juan A. Anguiano and Steven Jones, Murphy Exploration and Production Inc

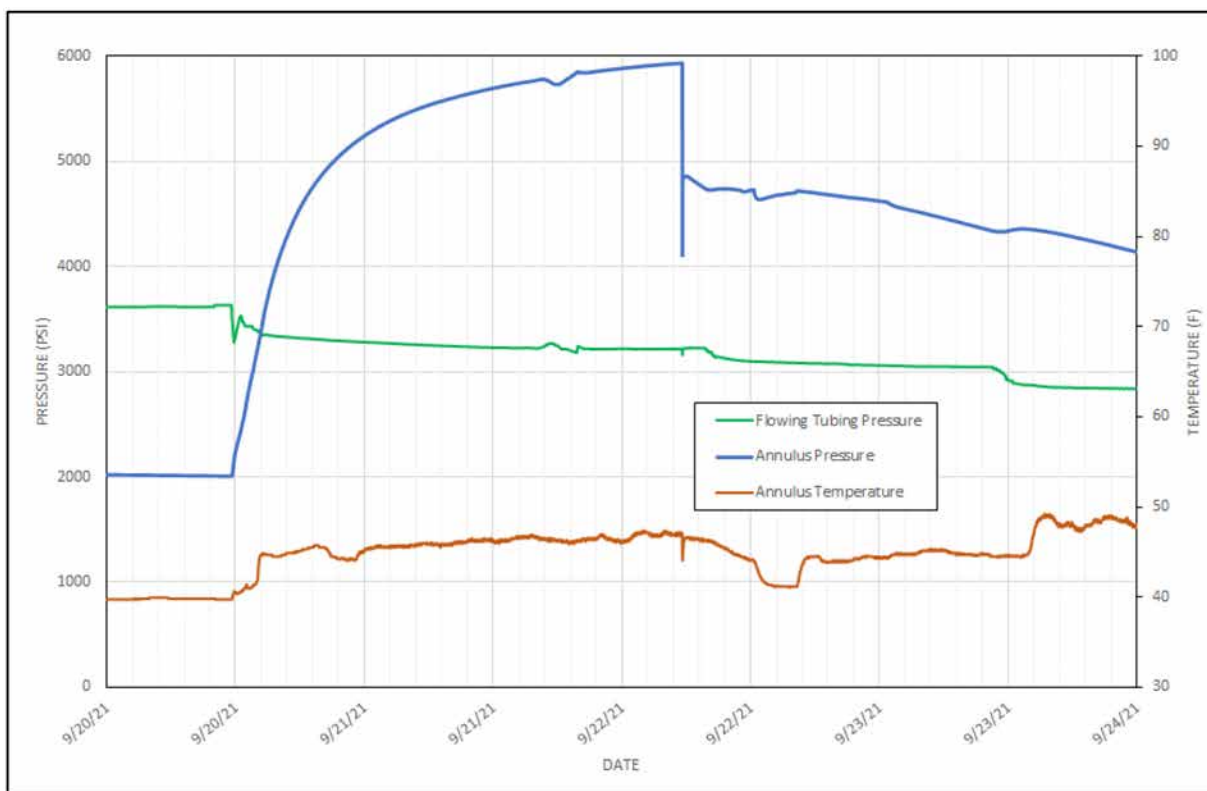
Figure 2—Well Start-Up Leak Event Following

As a prudent precautionary measure, production operations on the subject well were ceased prior to hurricane Ida in September of 2021. The well was brought back on production on September 20th and as the well begin to warm, the annular pressure began to build as is typical with the increase in temperature. Over the course of the next day, the annular pressure asymptotically approached the typical annular operating pressure of around 6,000 psi. At 5:39 on September 22nd, an annular pressure loss event occurred wherein the pressure suddenly dropped from about 5,900 psi to 4,100 psi. (Figure 2.) The pressure in the annulus recovered to about 4,800 psi but then experienced a decline over the next few days.

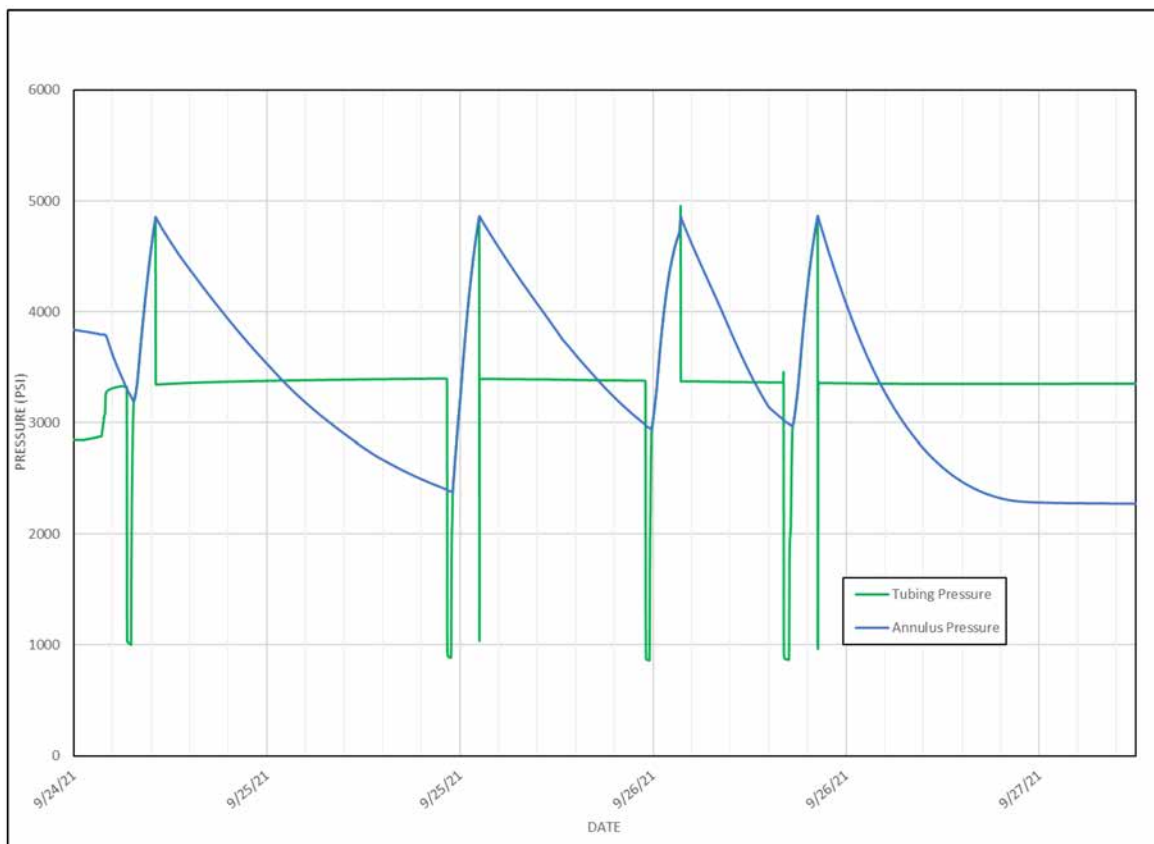
Figure 3—Well Start-Up Leak Event – Follow Up Pressure Tests

In order to diagnose the pressure anomaly, the well was shut in and a series of pressure tests were performed on the annulus. This was done by pressuring the annulus using methanol to about 4,800 psi and monitoring the results. Four pressure cycles were performed, each with a resulting higher leak off rate than the previous. (Figure 3) The first leak off rate was 180 psi/hr and the final leak off rate was about 375 psi/hr. Based upon the pressure behavior in the annulus and taking into account the compressibility of the liquid therein, the leak rate was calculated to range from 0.15 l/m to 1.5 l/m.

The shut-in tubing pressure of the well is on the order of 3,600 psi. Referring again to Figure 3, it is noted that the annular pressure reaches equilibrium at approximately 2,200 psi. The 'A' annulus contains 12.7 ppg fluid and the 'B' annulus contains 12.9 ppg fluid. The hydrostatic head of the 'A' annulus fluid (12.7 ppg) column compared to that of the tubing pressures suggest that the tubing pressure integrity is not compromised. However, this pressure equilibrium corresponds roughly with the hydrostatic differentials between the B and A annuli. In addition, the equilibrium pressure is comparable to the pore pressure at the 11 7/8" liner shoe. This suggests that there is a flow path into the B annulus and some communication to the formation outside that volume to the formation. Additionally, a cement bond log taken at the tie back assembly and 9-7/8" liner indicates the cement is poor in this area which would facilitate potential communication.

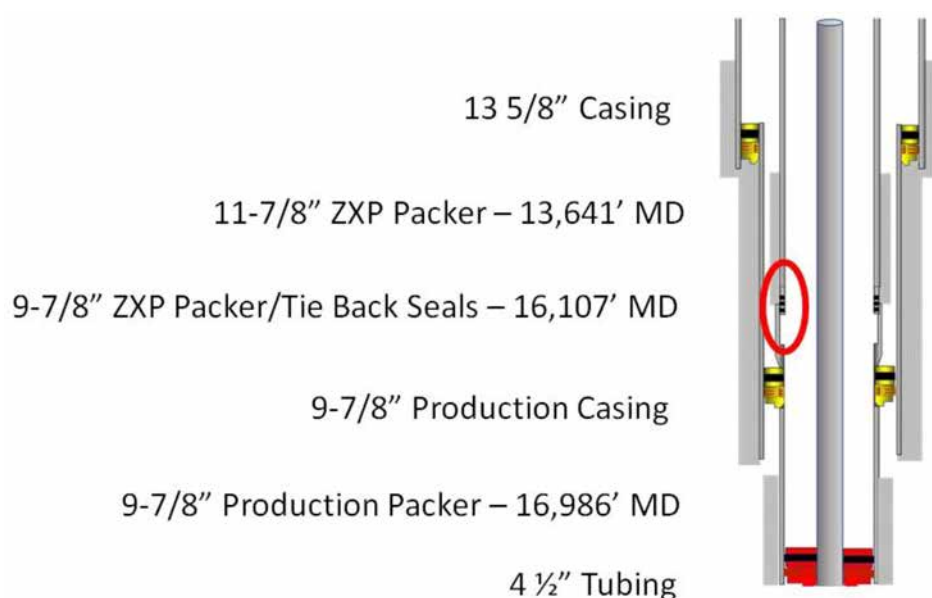
Figure 4—Suspected Failure Point

After concluding the pressure testing, the well conditions and well history were thoroughly analyzed to determine potential failure points causing the issue. Armed with this information a suitable path forward toward remediation could be formulated. Figure 4 shows an expanded view of the suspected failure point at the 9-7/8 production tie back seals. The following discusses supporting information leading to this supposition.

Another concern on this area arises from the operating envelope of the 9-7/8" tie back extension assembly. A bleed down of the applied pressure to the 'A' annulus pressure occurred on a number of occasions previous to the pressure event in discussion. The 'A' annulus applied pressure was bled to around 1,500 psi. When these pressure bleeds occurred, the differential pressure across tie back extension assembly potentially exceeded the collapse pressure of 2,460 psi. (Figure 5) Considering the hydrostatic pressure on the 'A' and 'B' annuli, and accounting for an estimated annular pressure buildup of 4,000 psi in the 'B' annulus due to warming of this fixed volume, the collapse was exceeded by about 2,000 psi. This certainly could have damaged or significantly weakened the tieback extension.

A final consideration when reviewing the tie back extension as a possible failure point is the engagement of the seal itself. A review of this assembly stack up indicated that there was only partial (approximately four) feet of seal engagement. Due to piston and ballooning effects, this seal had a potential for substantial movement. Pipe stretch calculations indicated as much as three feet of movement was possible leaving potentially only one foot of seal engagement.

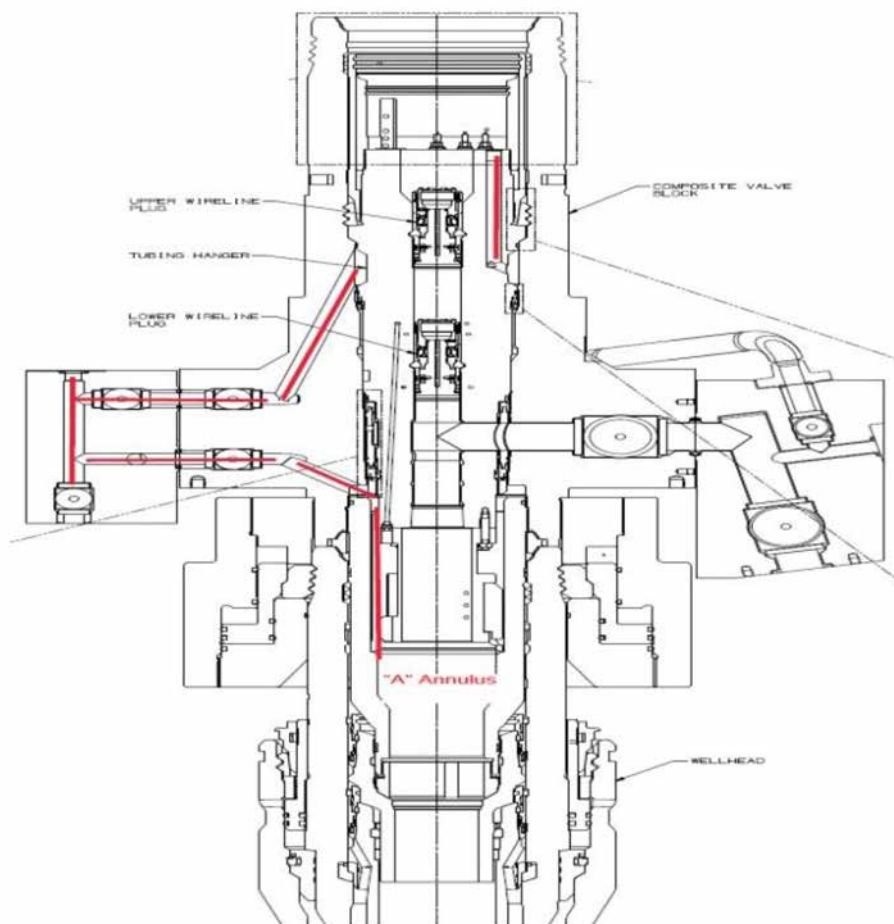
Figure 8—Annular Flow Path

When reviewing the specifications of well head equipment, it was noted that the flow path to the annulus through the internal tree cap (ITC) had a restriction of 0.156 inches. The sealant blend selected for this operation would be too aggressive to be passed through this restriction. Therefore, an external tree cap (ETC) was modified which provided for a suitable flow path to the annulus. The ITC was to be removed and replaced with the ETC prior to lube and bleed operations. (Figure 8) The sealant then could enter the A annulus through via the hot stab into the receptacle on the ROV panel of the modified ETC. (Figure 9) An SIT was performed to verify that liquid sealant could be applied through a representation of this setup successfully without experiencing a pressure drop that would cause it to solidify prematurely.

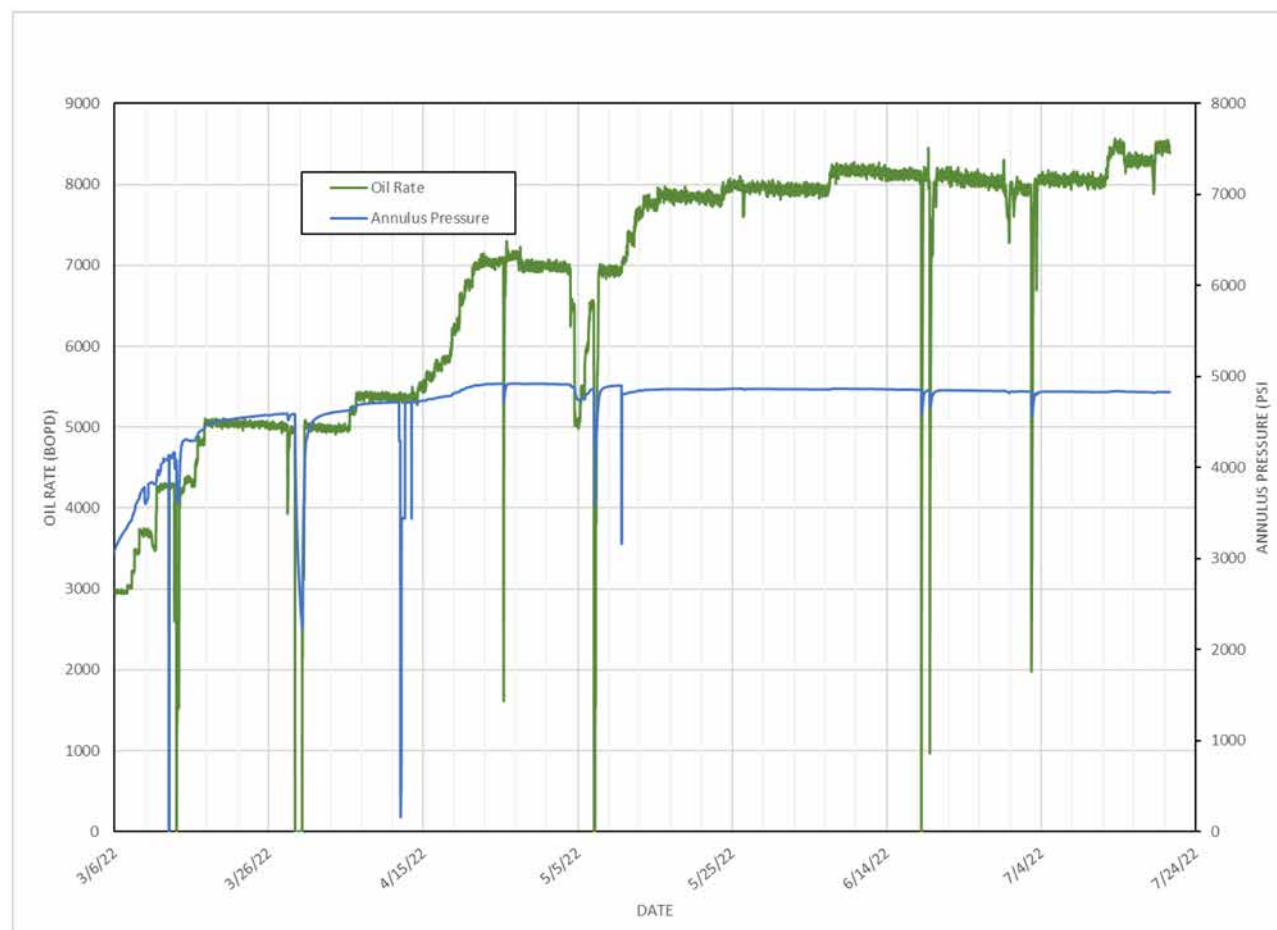
Figure 11—Annular Pressure and Rate Trend

After placing the sealant in the annulus, twelve hours was allowed to assure that the all of the material had time to settle on the packer and accumulate to the desired depth. Following this, the well was brought on line to induce warming and thereby increase the annular pressure. The production rate was brought up in increments as to maintain control over the annular pressure and not exceed the operating pressure envelope. The original pressure event occurred when the annular pressure approached 6,000 psi. The annular pressure limit was set to 5,000 psi as a precautionary measure. The production rate was gradually brought up over the following weeks allowing the temperature and annular pressure to reach steady state. (Figure 11) Following this, the rate was safely increased to near the original production rate without another pressure loss event.
