**SPE-223453-MS**

## **Micro Tubing Leak Investigation with High Resolution Detection Technology and Leak Remediation with Pressure Activated Sealant – A Case Study**

Azamat Kantarbayev and Tilek Jumamukhambetov, NCOC N.V., Atyrau, Kazakhstan

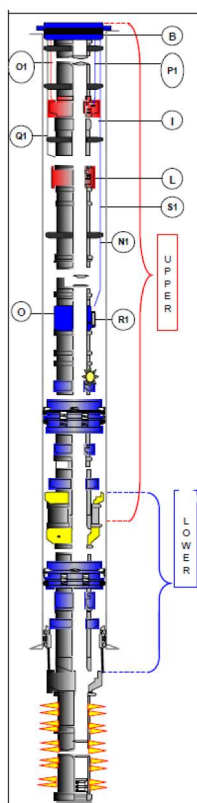
Figure 2—Generalized Well A Completion Schematic

In autumn 2018, the leak detection operations with the use of spectral noise-temperature logging service were deployed on slickline. The leak has been identified at the depth of TR-SCSSV, being confirmed afterwards that communication point is located at just below the TR-SCSSV flapper. After the leak investigation well was secured by fully sweetening with diesel down to top of perforation intervals and installing two downhole plugs as barriers.

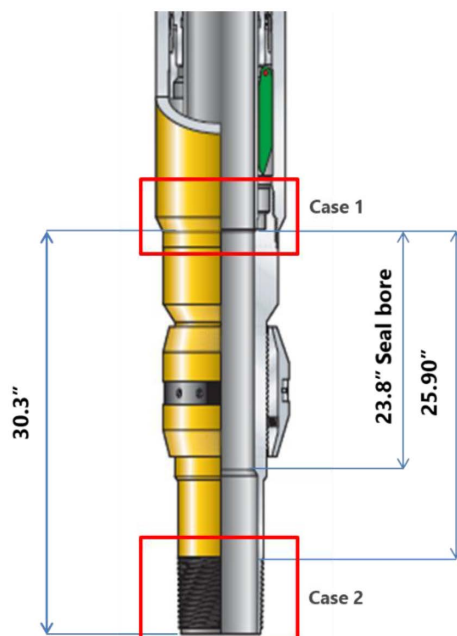
Figure 3—Potential leak paths below the flapper

2. There are two potential leak paths just below the flapper:
  - o Case 1 indicates the leak at the TR-SCSSV body thread, while Case 2 indicates the leak at the connection between TR-SCSSV and the lower pup joint.

- o In case 1, the body thread is only 8.6 in below the flapper. Mechanical remediation cannot be installed without jeopardizing the functioning of the TR-SCSSV.

- o In case 2, the TR-SCSSV lower seal bore is only 23.8 in long and just 8.6 in below the flapper itself, hence the straddle tool should be specially designed to allow top of the straddle to sit precisely below the flapper and seal against the TR-SCSSV lower seal bore.

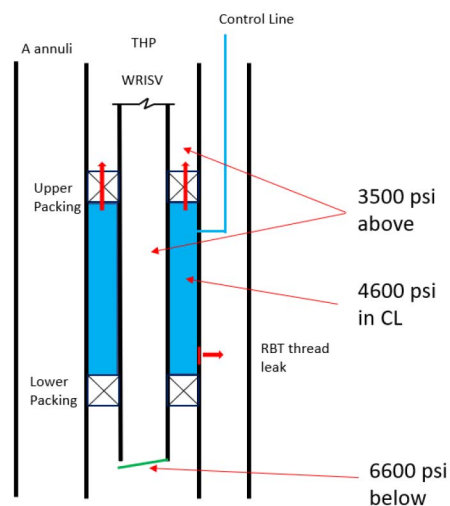
Figure 6—Simplified depiction of targeted downhole system

Prior to the job, an acoustic leak detection identified a leak at the threaded connection at the bottom of the safety valve mandrel. In addition, a potential small leak was suspected at the control line connection to the SCSSV mandrel. The leak rate was measured at 45 ml/min in shut-in conditions.

The sealant was to be pumped down the control line into the chamber which is bound by the leaking threaded connection. The volume of this chamber is 4.3 liters, yielding a total system volume of 6.235 liters. The targeted section's parameters were as follows: Control Line  $\frac{1}{4}$ ", Inc. 825, WT=0.065", ID=0.12". Communication channel punched between insert safety valve and CL is round shaped, ID=0.188".

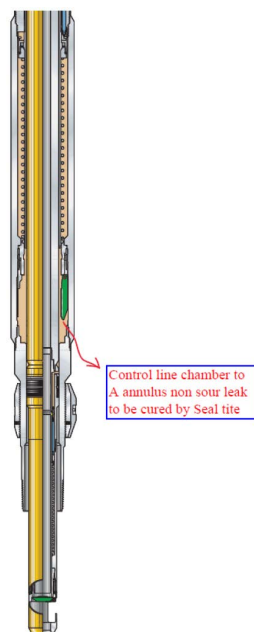
Figure 7—After installation of WR-SCSSV inside TR-SCSSV, RBT-6 thread leak turned into control line to A-annulus hydraulic leak

Note that after the insert valve installation, we checked the leak again. While injecting the sealant, we realized that the leak was bigger due to WRSSV upper seal failure.

Tubing integrity was reinstated by the installation of WR-SCSSV into the existing TR-SCSSV and successfully inflow-tested several times. However, CL pressure test at 11,000 psi was not successful. CL fluid leaked through RBT-6 thread into A-annulus measured at 65 liters per day leak rate during well opening. The well was subsequently shut-in until further remediation plan for the CL system.

The remediation sequence for the sealant injection included the pumping of 2.5-3 liters of hydraulic fluid (re-establish injection rates) followed by injection of 2 liters of sealant until the initial pressure hold is obtained at lower pressure ~6,000-8,000 psi, with subsequent increase to 13,000 psi in gradual steps.

The abovementioned sealant treatment sequence was then reiterated three times due to the creation of a temporary seal. Following the initial treatments, a third was performed up to 13,000 psi creating a seal that held for over 20 hours, however the seal was lost after performing the standard pressure cycles to open and close the WR-SCSSV valve due to unknown downhole conditions.

Subsequently, a fourth sealant pill was injected, ultimately creating a resilient seal which allowed for the well to be opened for production in Spring 2022. The seal had subsequently held firm during regular 1-yearly well integrity checks and remains in place at the date of this paper publication.
