**SPE-228278-MS**

## **Use of Pressure-Activated Sealants to Repair Leaking Subsea Horizontal Tree Connectors (Unlatch HXT)**

A. Burgess, Seal-Tite International, Madisonville, LA, USA; S. Carpenter, Santos Pty Ltd., Perth, Australia; C. Anderson, Seal-Tite International, Madisonville, LA, USA

This paper was prepared for presentation at the SPE Subsea Well Intervention Symposium held in Galveston, Texas, USA, 19-21 August 2025.

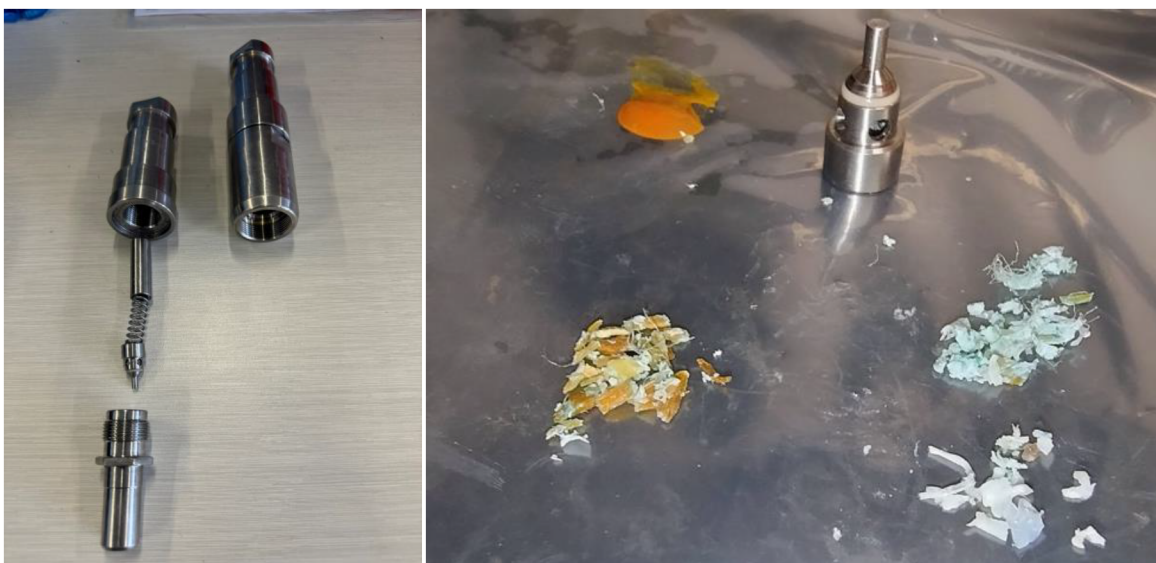
Figure 4—(a) Assembled and Disassembled Poppeted Coupler; (b) Poppet from Blocked Connector with Blockage Material Separated by Type

A very aggressive and highly viscous sealant blend was deployed during the initial treatment, however, during its injection, challenges were encountered. The RWOCS plate mated to the HXT TCU/TCL system with poppeted couplers (See Figure 4a below), were equipped with four 1/8" holes for the injected fluid to flow through. Due to the rheological properties of the sealant, debris within the system was swept into the small ID poppet holes and served to further restrict flow, generating sufficient differential to cause premature sealant polymerization at these connectors. Once no further injectivity was possible, the RWOCS plate was recovered to surface and the connectors were examined as seen in Figure 4b below. The 3 pictured materials are a combination of thread sealant applied during skid make up, particulates within the system, as well as polymerized pressure-activated sealant.

From this point, all subsequent repairs were performed using the same two sealant blends. The first of which was sent to location in concentrate form and blended with fresh water prior to charging the accumulator. The other was sent out in "neat" form, however, the severity of the observed leaks necessitated the addition of a viscosifying agent to aid in generating differential pressure, thus improving sealant activation. Small changes to the blend ratios and components were made as needed on an individual connector basis.
