OTC 23941-MS

Rigless Repair of Subsea Tubing Leaks Using Pressure Activated Sealant

Case Study – Well “A”

Case Study – Well “B”

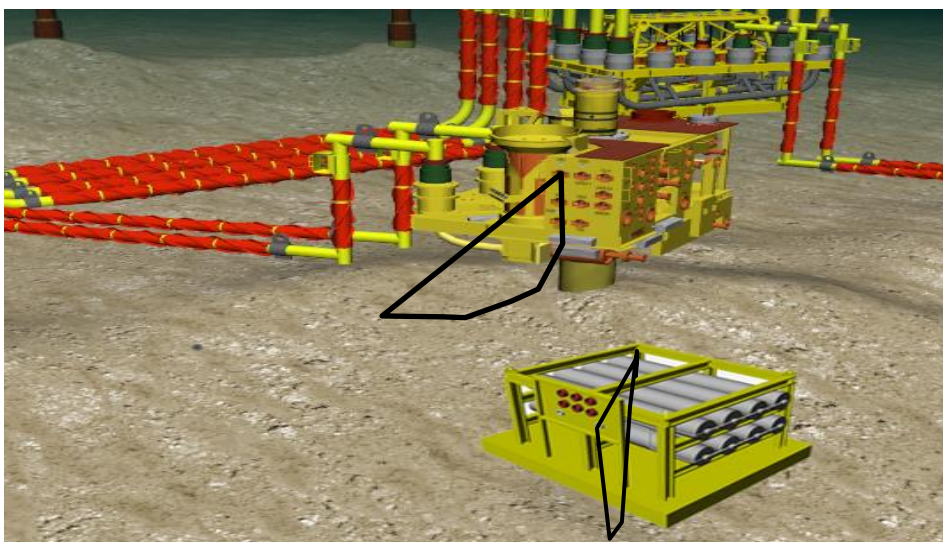
The subsea delivery system (Figure 1) was designed as a system of eight manifolded accumulators mounted on a typical subsea mud mat. A piston installed in each cylinder allowed filling with sealant on one side and then a power fluid applied on the other side of the piston to force sealant into the well. The skid was configured to allow injection of power fluid by the ROV or by utilizing ambient seawater hydrostatic pressure to drive the piston. Since the well annulus pressure was substantially below ambient hydrostatic, the seawater option was selected as the primary drive for this application.

Figure 1. Subsea Delivery Skid

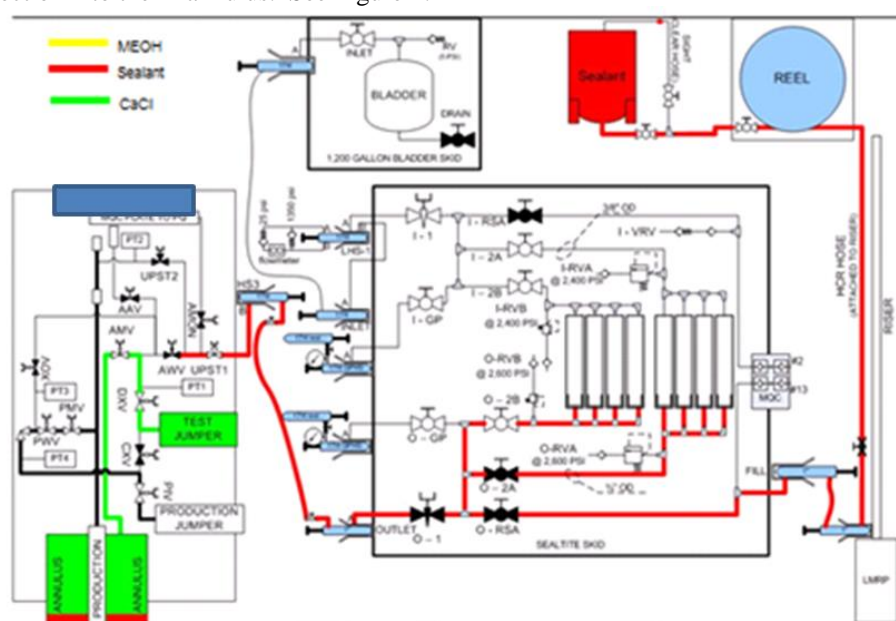
During field development, the project team had the foresight to include a hot stab port providing direct access for fluid injection into the A-annulus. See Figure 2.

Figure 2. Injection Schematic

This provided the sealant with a flow path that minimized restrictions that could have caused unintentional pressure drops and unwanted sealant activation. The total volume of the eight cylinders was 11 bbls. Since the planned injection volume was 75 bbls, provisions for refill of the cylinders was necessary. It was already known that a MODU would be stationed on the same well template performing drilling operations on an adjacent well. This would allow the MODU to be used as the work platform for sealant blending and storage. A 1" line would be strapped to the drilling riser and serve as the flow conduit from surface to the subsea skid for sealant refill.

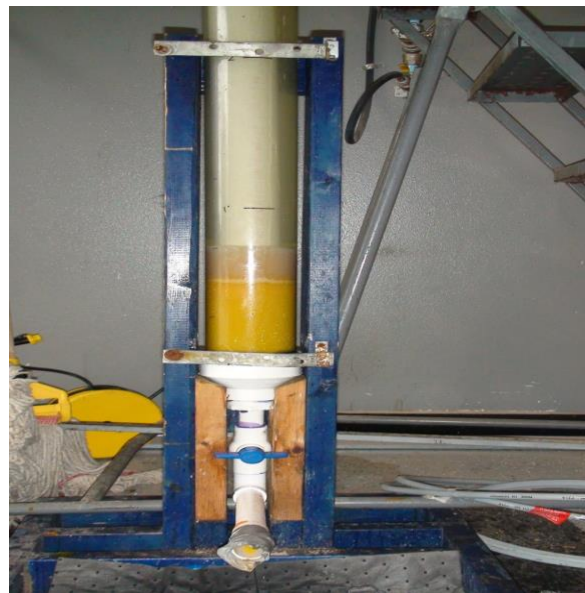
Fall Tests – To simulate the wellbore, one liter of 12.1 ppg sealant was poured into a 4" x 10' column of 10.8 ppg CaCl₂ brine. See Figure 3. The sealant fell through the brine (upper clear layer) at an average rate of 1 ft/sec and consolidated at the bottom of the column. Sealant integrity was satisfactory with volume loss less than 1%. The Flo-Seal SS is seen at the bottom of the column (the yellow layer). The next tan layer is a gel pad which was originally at the bottom of the tube. The sealant blend displaced this gel pad and pushed to the bottom, indicating the ability to move heavy fluids by gravity settlement.

Figure 3. Sealant Test Column

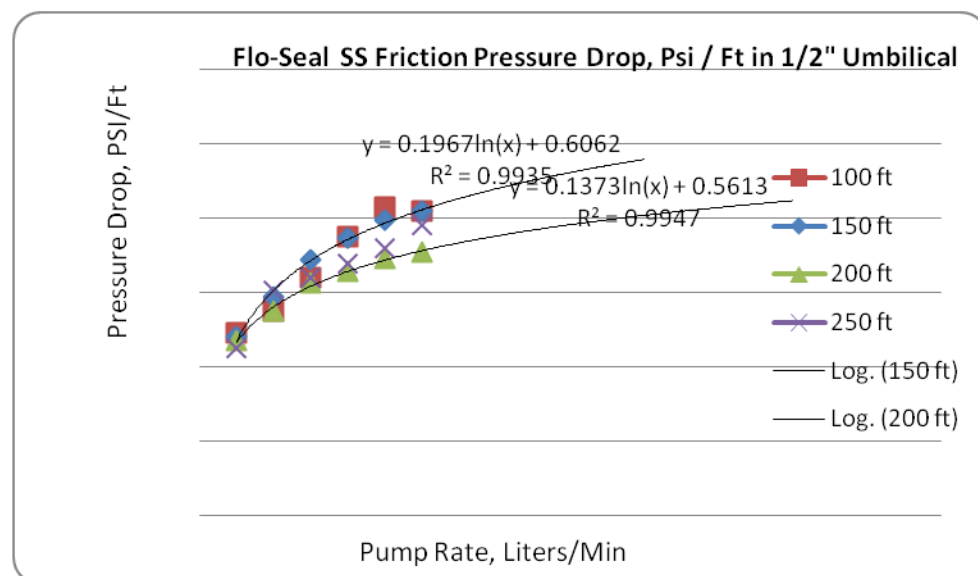
Friction Pressure Loss – A second flow loop consisting of 450' of ½" nylon-lined umbilical was prepared. Sealant was circulated at various rates under subsea temperature conditions (38 F). The sealant exhibited pseudoplastic flow performance with unit friction pressure loss decreasing with increasing pump rate. See Figure 4. This data was used to predict the expected pumping requirements during the repair.

Figure 4. Sealant Flow Performance

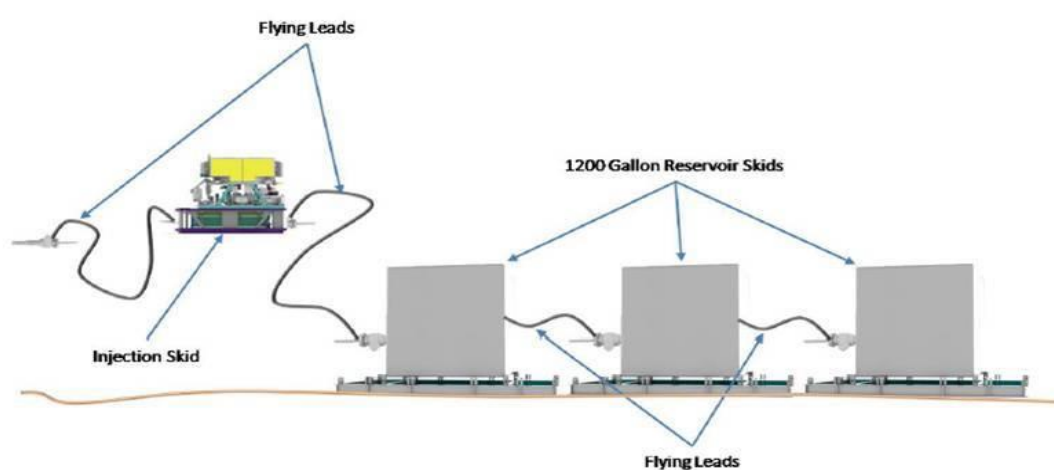
The lessons learned during the equipment development for the successful 2009 tubing repair project helped to shorten the review process. Since a rig would not be available as a work platform, all work would have to be performed from a Dive Support Vessel. The team selected a system utilizing subsea bladders for sealant storage and a subsea pump for sealant injection. See Figure 5. These would be connected and controlled with an ROV and jumpers. The jumper system made retrieval and replacement of the bladder systems a simple operation.

Figure 5. Sealant Injection System

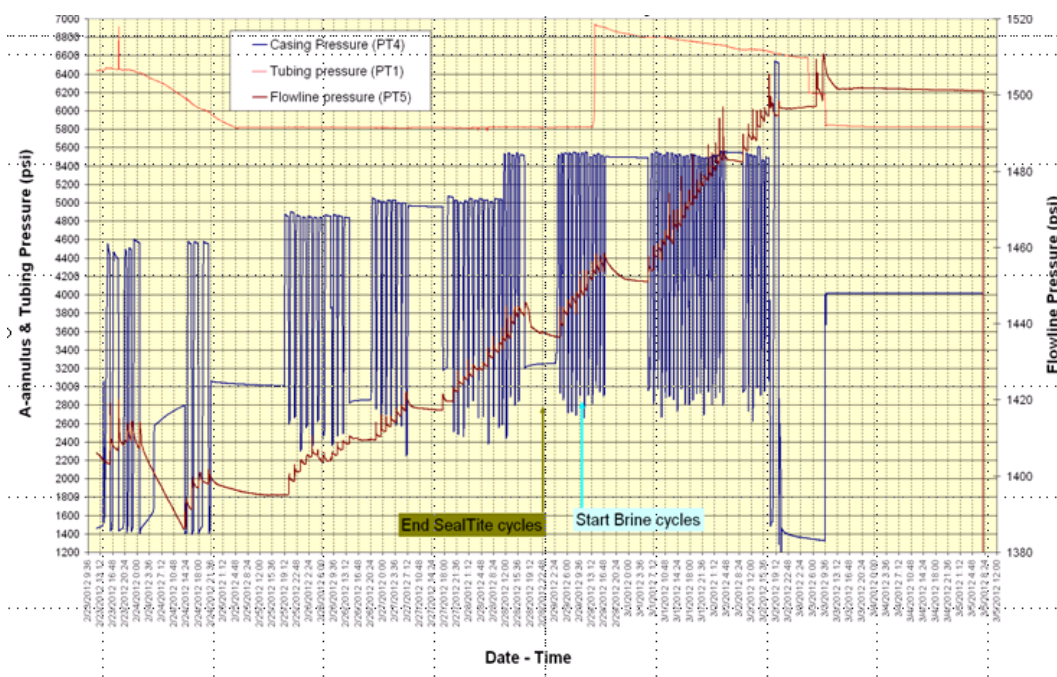
The operation was conducted in March 2012. Sealant was injected using a “Lube and Bleed” process similar to the Well A operation. The chart below shows the lube and bleed cycles associated with the work and illustrates the consistency of the repair procedure. See Figure 6. Once all injection fluids were in the well, the annulus pressure was increased to fully activate the sealant, then reduced for performance monitoring. The flat line observed on the chart demonstrates the successful repair of the two-way communication.

Figure 6. Lube and Bleed Cycles
