Technical  
Conference  
Paper

# **Annulus Communications Eliminated using Pressure-Activated Sealant**

Spring 2005 Conference  
17-20 April  
Syracuse, New York, USA

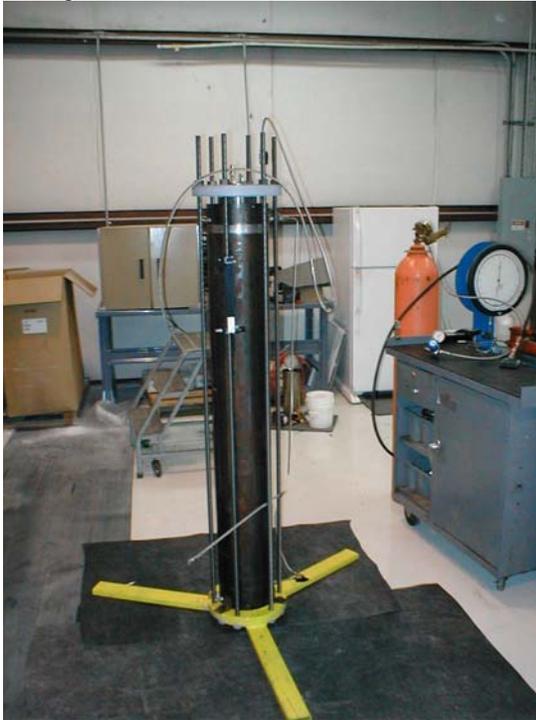
Figure 1: Microannulus Test Fixture

At their facility in Houston, Texas, CSI constructed a test fixture of two concentric casing strings—eight and five-eighths and four inches in diameter—welded together with base and top plates, and tested to a 5000 psi pressure rating.

Cement was pumped into the annular space of the test fixture between the inner and outer casing strings. While the cement was curing, pressure was maintained in the inner string. Once the cement is cured, the inner casing pressure was released, creating an annular void space between the inner casing and the cement sheath. The release of pressure resulted in the creation of cracks and fissures in the cement.

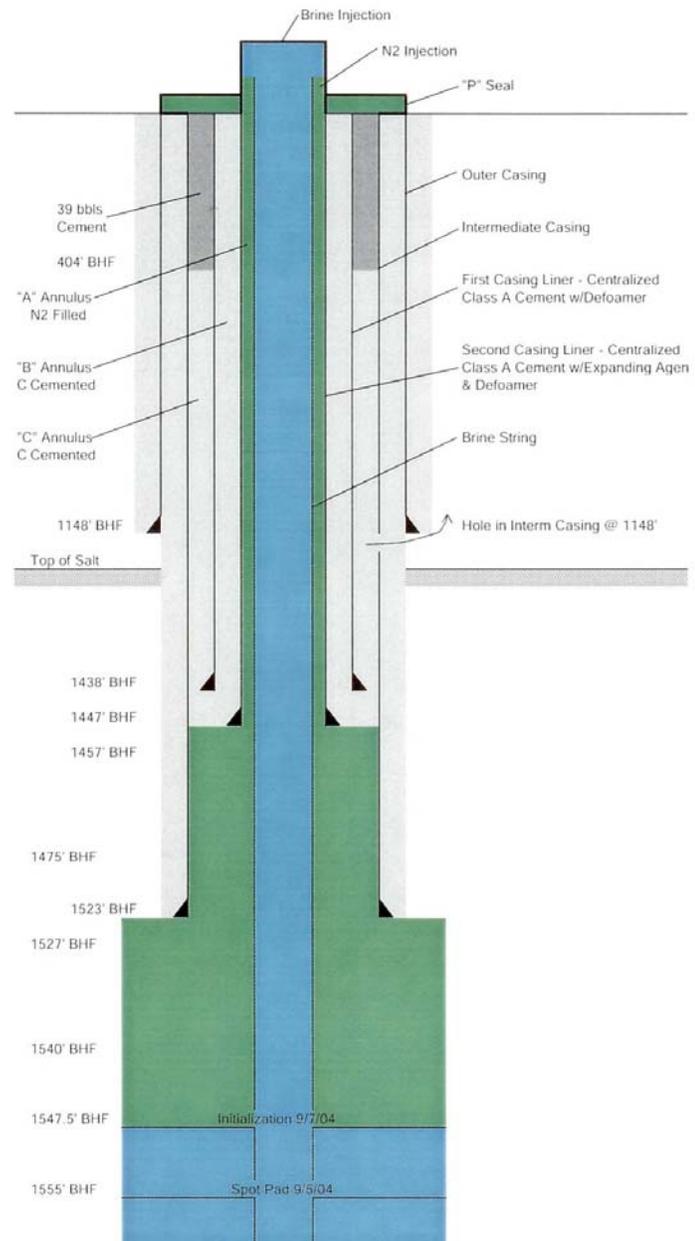
Figure 3 – Wellbore Schematic

Well Background. The crude oil storage well was originally drilled in the late 1970's. A wellbore schematic for subject well is shown in Figure 3. Recently, a new casing liner ("first casing liner" as designated on Figure 3) was run inside existing casing to a total depth of 1471 ft. The first casing liner was run with centralizers and cemented with Class A cement and a defoamer. After installation, a mechanical integrity test was performed to 1500 psi on the casing liner and the casing failed the test. Subsequently, a new second casing liner was run with centralizers and cemented with Class A cement and an expanding agent. A brine string was installed to pump brine into the cavern.

Further mechanical integrity tests were performed in late 2004. These tests identified the problem as microannulus leaks in the "B" annulus and/or "C" annulus as designated on Figure 3. The pressure build-up rates are shown in Figure 4.

Sealant Solution. With brine in the cavern and brine string and Nitrogen in the “A” annulus from surface to a few feet below the Second Casing Liner shoe, 150 gallons of oil based sealant was pumped into the “A” annulus and allowed to fall through the Nitrogen to the Nitrogen/Brine interface. The sealant treatment was designed to float on the brine in the well and cover the casing liner shoe. After sufficient time for the sealant to fall, the “B” and “C” annulus surface pressures were bled off to force sealant up the leaking cement columns to cure the microannulus leak(s). Over a thirty-six (36) hour period, the annuli were alternatively bled-off and closed to cycle pressure on the annuli. During each cycle, the rate of pressure build-up was recorded as shown in Figure 5. As can be seen from the Post-Sealant Build-up Rate information, each cycling of pressure resulted in a reduction in the rate of pressure build-up.

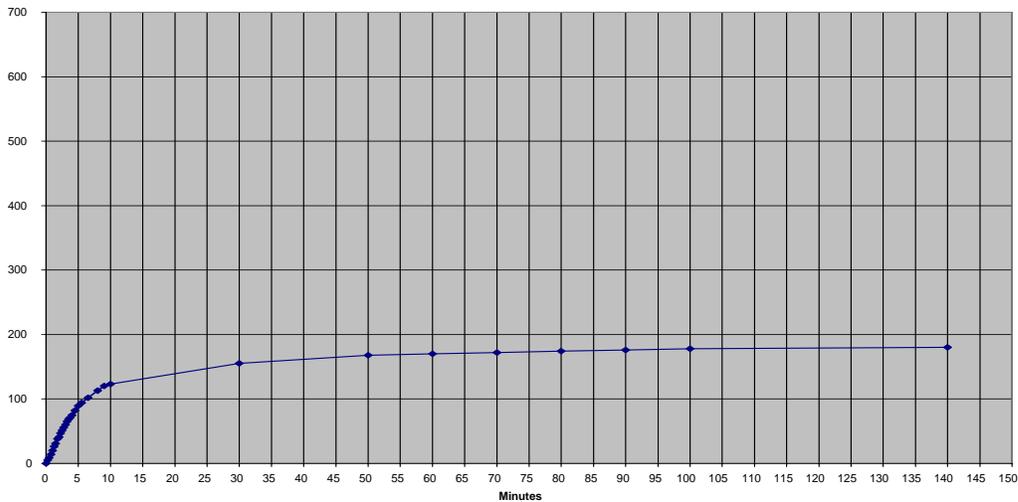
**Figure 6 – Post-Sealant Build-up Rates (80 Minutes)**

As can be seen from the graph shown in Figure 6, after the sealant treatment, the pressure stabilized at just below 200 psi.

Conclusion. After the sealant treatment the well was retested and passed the required MIT. The crude oil cavern storage well was put back into operation.
