SPE 91399

Microannulus Leaks Repaired with Pressure-Activated Sealant

David W. Rusch, SPE / Seal-Tite International;
Fred Sabins, SPE / Cementing Solutions, Inc.; and
John Aslakson, SPE / W&T Offshore, Inc.

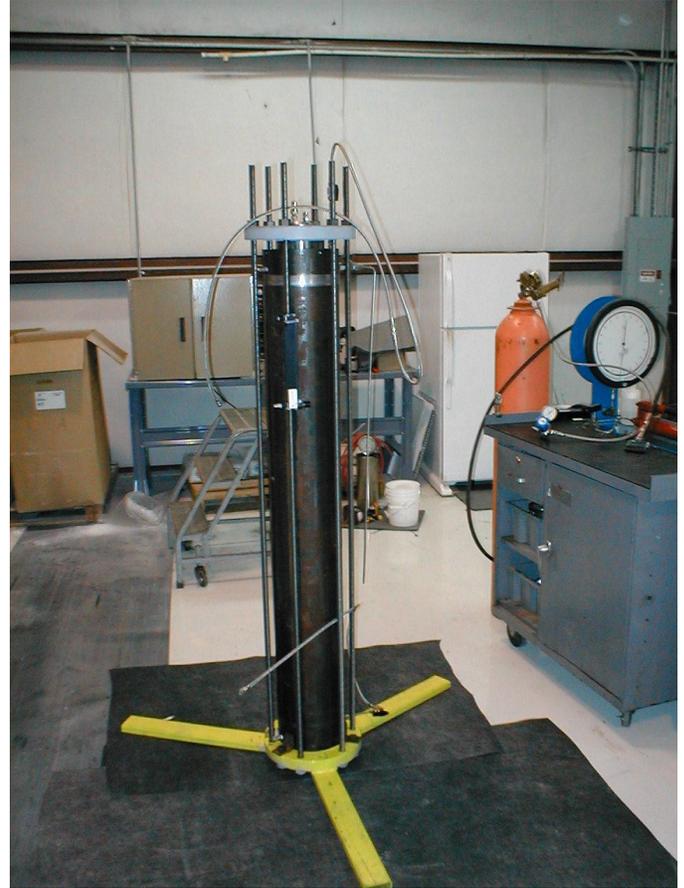
At their facility in Houston, Texas, CSI constructed a test fixture of two concentric casing strings—eight and five-eighths and four inches in diameter—welded together with base and top plates, and tested to a 5000 psi pressure rating.

Figure 1: Microannulus Test Fixture

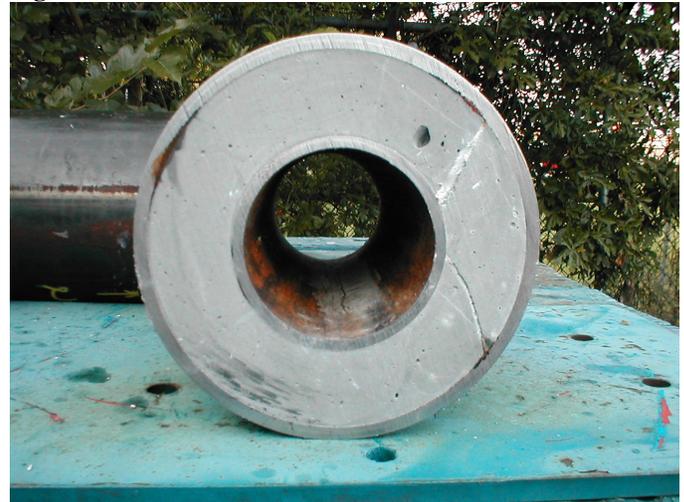
Cement was pumped into the annular space of the test fixture between the inner and outer casing strings. While the cement was curing, pressure was maintained in the inner string. Once the cement is cured, the inner casing pressure was released, creating an annular void space between the inner casing and the cement sheath. The release of pressure resulted in the creation of cracks and fissures in the cement.

Figure 2: Annular Cross-Section – Test Fixture
