# Use of Pressure-activated Sealant for Repair of Deepwater Drilling Riser Leaks – A Case Study

D. Neil Cary  
Vic Groomer  
Bryan Sanchez  
Steve Hiltbold  
Steve O'Leary

Seal-Tite International  
Seal-Tite International  
Transocean Offshore Deepwater Drilling, Inc.  
Transocean Offshore Deepwater Drilling, Inc.  
Transocean Offshore Deepwater Drilling, Inc.

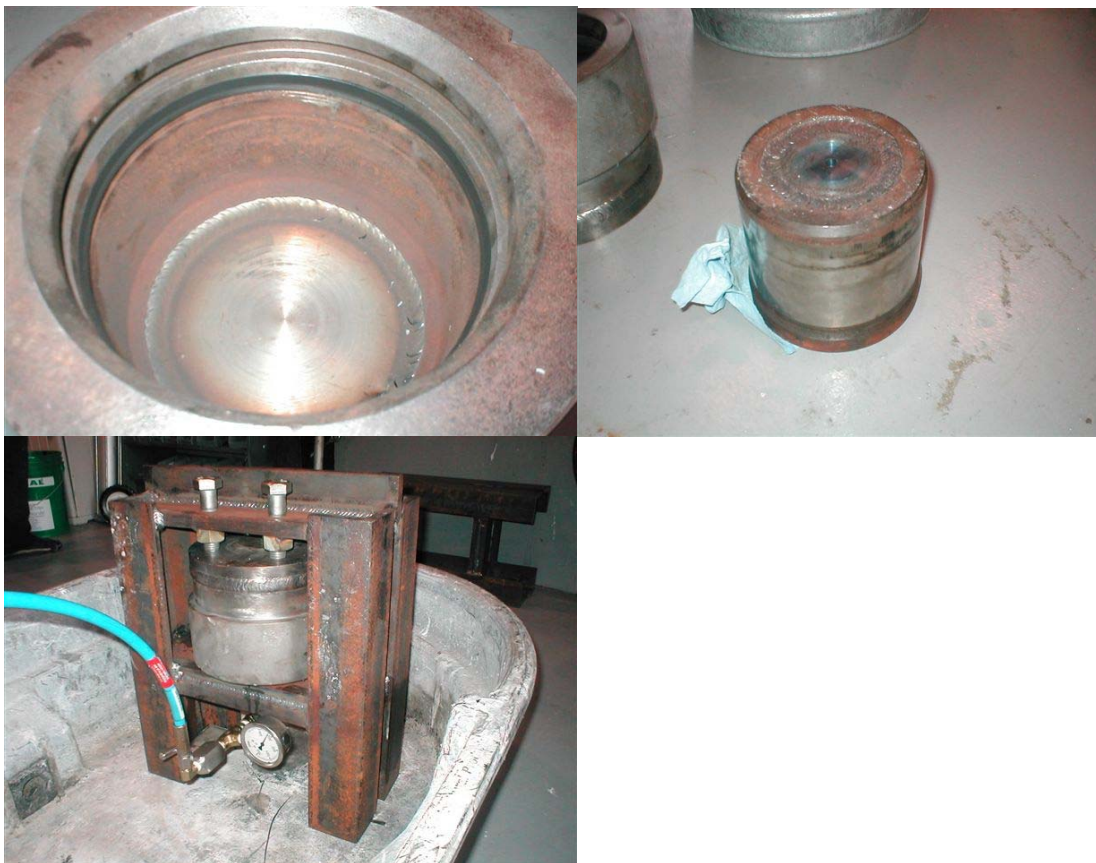
Transocean provided to Seal-Tite a typical pin-and-box connection from a 4" I.D. riser choke line. The open ends of the tubes were seal-welded and injection/pressure monitoring ports were added. Due to the significant separation forces that high pressure testing would create, a containment frame was constructed to house the connections and allow safe observation of the testing activities. Below are photographs of the pin/box connection and the testing frame.

The seal employed on this connection is a standard "polypack" arrangement consisting of two 95 Durometer Viton seals each with 6" I.D. x 6 1/2" O.D. spaced approximately 1" apart. The seals were removed from the housing and damaged with a hacksaw, then reinserted into the housing. The unit was then assembled and water injected into the housing to evaluate the leak severity at various injection pressures. Pressure-activated sealant was then injected into the housing and squeezed into the leaking seals. The repaired seals were then tested to 5000 psi for 6 hours. Once a successful test had been recorded at the initial leak rate, the seals were removed and cleaned. The seals surfaces were damaged further to increase the leak rate and reinstalled. The sealant injection and testing process was then repeated for the increased leak rate.

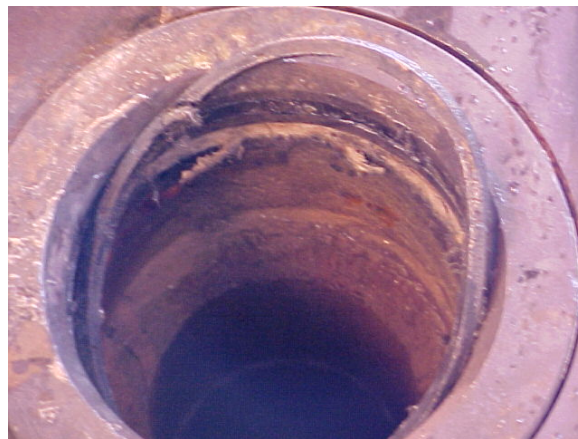
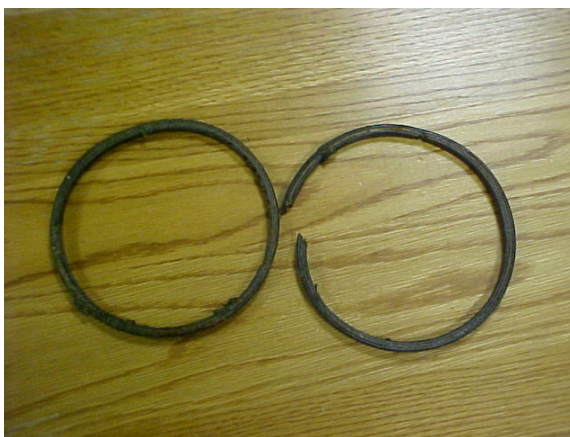
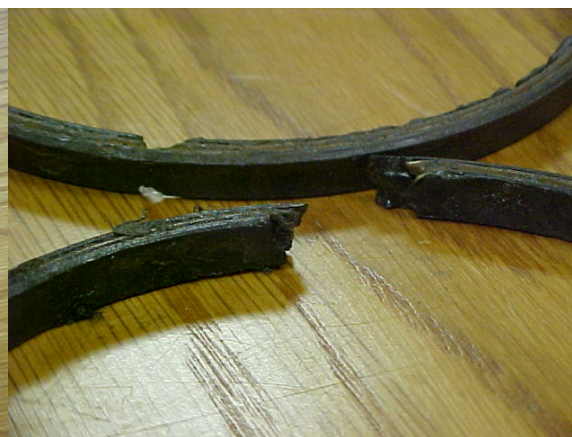
During this repair the riser was subjected to severe loop currents as high as 2.6 knots. These currents caused significant oscillation in the riser, and clearly had an impact on the repair as a small amount of sealant could be seen coming from the leak point with each oscillation of the riser. It is logical to assume that this movement also contributes to abnormal wear of the polypack seals.

The well was then taken to TD over the next 30 days. Normally the BOP/Riser equipment would be tested every 14 days. However to provide maximum confidence in the sealant process, the choke line was successfully tested to 7500 psi every three days. Once the well had been suspended, the riser was pulled to the leaking connection and the damaged seals removed for inspection. Below are photos of the riser stack and seal subs as they were removed. It can be seen that one of the polypack seals was completely separated. The second polypack seal had significant damage to the seal areas.

The Marianas was equipped with a typical cementing unit including two 10 bbl paddle-type blending tanks. To ensure accurate system volumes a dye pill was displaced to the leak site while volumes were carefully monitored. A 2.5 bbl sealant pill was prepared in one 10 bbl tank while the second tank was utilized to prepare 3 bbls of gel pad. The gel pad was only used to help protect the sealant pill – one barrel was pumped ahead of the sealant and 2 bbls were pumped behind. The sealant was displaced to the leaking connection with seawater by circulating down the choke line and taking returns on the kill line. Once in position the BOP crossover valve was closed and sealant was squeezed into the leaking seals. Over the next 12 hours the sealant injection pressure was steadily increased until an 8000 psi seal was achieved. This pressure was held for 8 hours to allow the sealant to cure, during which no significant pressure bleedoff was observed. The sealant was then flushed from the system and the choke line tested to 7500 psi, allowing normal drilling operations to resume.
