SPE 96432

## Use of Pressure-Activated Sealant To Cure Leaks in Subsea Wells - A Case Study in Campos Basin

Valdo F. Rodrigues, SPE, Gualter G. Gonçalves, Petroleo Brasileiro S. A; David W. Rusch, Joaquim L. Videira, Seal-Tite International

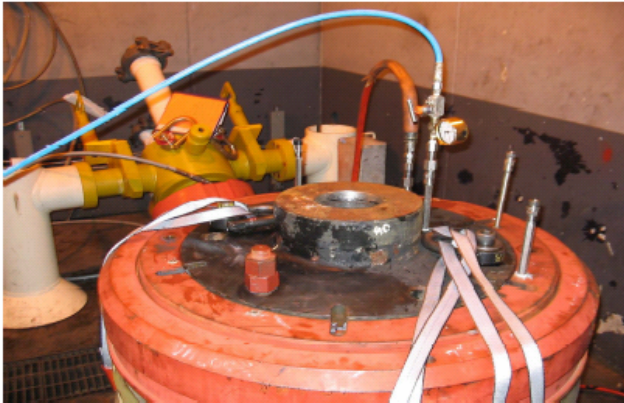
Figure 1. Sealant efficiency test on a flowline hub

According to Petrobras laboratory tests and field applications the sealants have never plugged a control line or damaged any component of a hydraulic system. The sealants do not react with or damage electronics or metal seals. Specific tests were carried out in umbilical lines and the SCSSV mechanisms. Replicated leaks were created in the fittings, connections and hoses of umbilical systems. Seals in SCSSVs were damaged or removed to create severe leaks. Using the sealant process, all leaks were cured except where the line was actually cut deeply through the control line. The flexible seals created were able to hold at the rated equipment pressure of 5000 psi. **Figure 1** shows a flow hub testing.

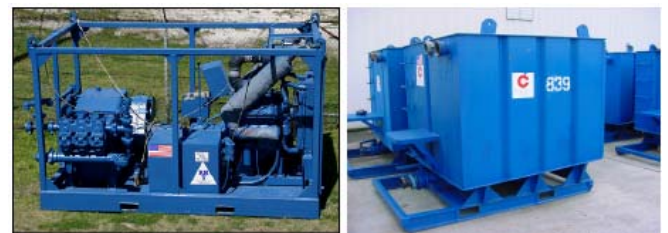
Figure 3b. Triplex pump and blend tank in the second case history

1. Rig up the triplex pump and blending tanks to the 4 in flowline and 2in gas lift line on the production unit. **Figure 3b**.
2. Test all equipment and discharge lines to 200 psi low and 2500 psi high.
