SOLUTION MINING RESEARCH INSTITUTE

Technical
Conference
Paper

REMEDICATION OF CASING AND MICROANNULUS CEMENT LEAKS UTILIZING PRESSURE ACTIVATED SEALANT

**SMRI Fall 2019 Conference
23-24 September 2019
Berlin, Germany**

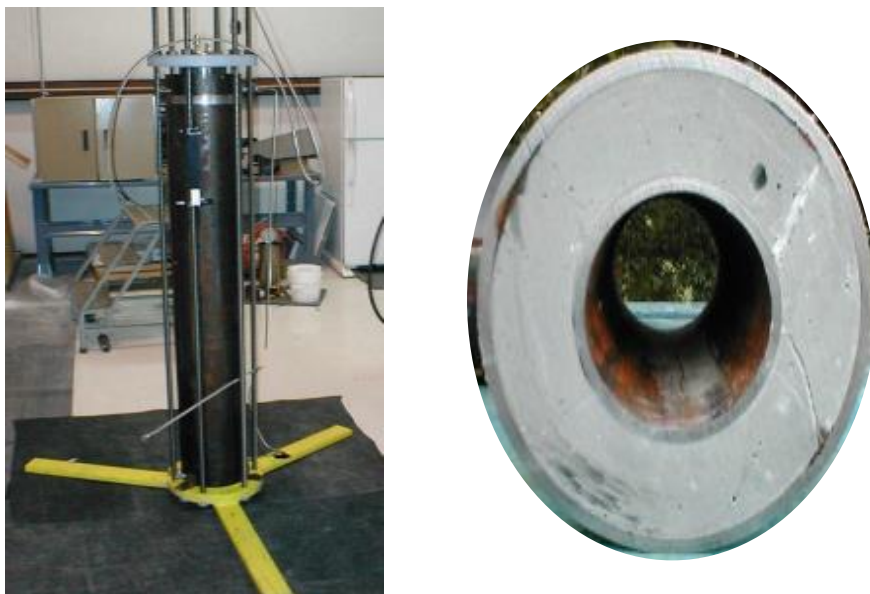
Figure 2. Microannulus Test Fixture and Cross Section from Rusch and Slezak, 2005

Realizing the need to develop a sealant formulation and procedure to seal microchannels and cracks that can develop in annulus cement, Rusch and Slezak, 2005 detail laboratory testing performed where a test annulus (See Figure 2 below) was created with fissures and cracks to model microannulus channeling. The permeability of these leak paths was confirmed and then treated with pressure activated sealant. Post-treatment, the integrity of the cement was restored to beyond the level of competent cement. This paper also provides three case studies which used pressure-activated sealant to restore wellbore integrity.

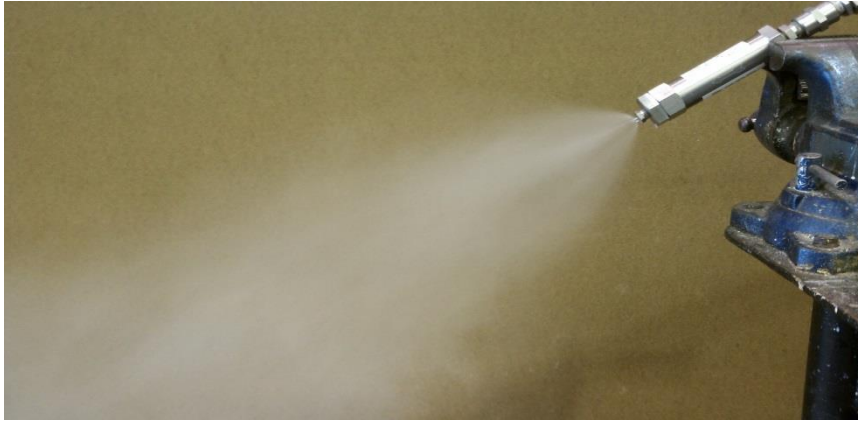
Figure 5: Misting Nozzle Atomizing Sealant

Atomizing sealant into the gas stream is ideal for small gas leaks where a liquid sealant approach may be unable to penetrate the leak site. In order to create the mist, a specially formulated blend of sealant that has been filtered is pumped through a nozzle with a 0.015" (0.381 mm) to 0.020" (0.508 mm) orifice (See Figure 5). The atomized sealant droplets are then carried with the gas stream through the leak site, where they accumulate and polymerize to seal the leak. This approach can be used for both casing shoe microannulus leaks and casing thread leaks.

This application requires careful monitoring of the pump rate and pump pressure because the misting nozzle is a source of significant differential pressure which can cause the sealant to polymerize. If this were to happen, the nozzle must be pulled out of the hole and changed to provide an optimal mist.
