SPE-212925-MS

Subsea Well Annular Integrity Repair Using Coiled Tubing and Pressure Activated Sealant

Joel E. Johns and Chris Anderson, Seal-Tite International; Juan A. Anguiano and Steven Jones, Murphy Exploration and Production Inc

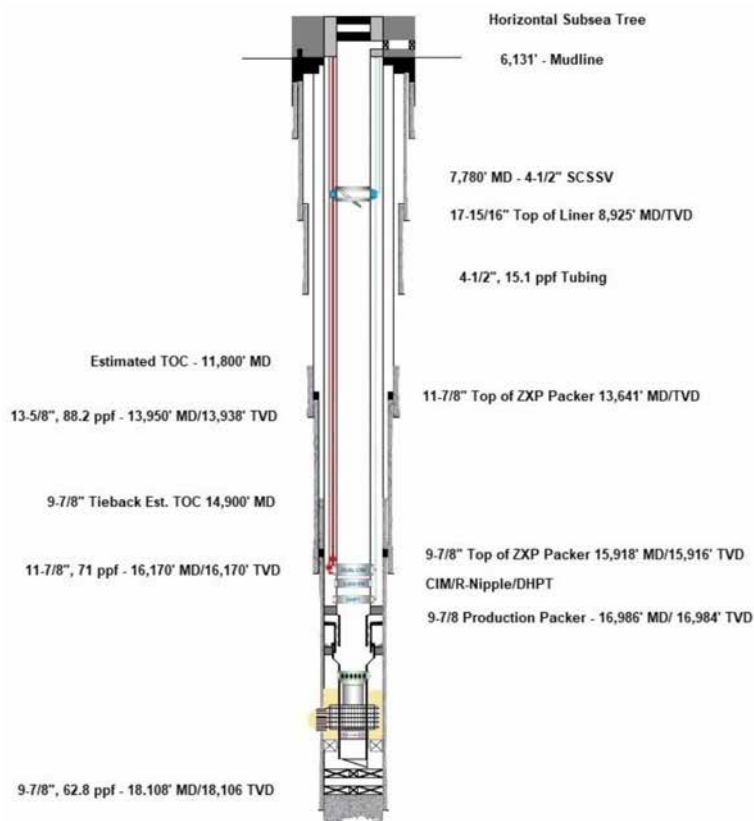
Figure 1—Subsea Wellbore Completion Schematic

The asset in discussion is a subsea well completed in 2015 in 6,131' of water. This vertical well completion consists of a 9-7/8 liner string set to 18,108' MD. The liner is tied back to the subsea tree from a liner top packer assembly at 15,918' MD. The well is a gravel-pack completion with 4-1/2" tubing down to a production packer set at a depth of 16,986' MD. (Figure 1) The completion fluid is 12.7 ppg calcium bromide. Prior to experiencing the annular pressure event, the well was producing 8000 bopd and 16 MMscfd.
