**SPE-223453-MS**

## **Micro Tubing Leak Investigation with High Resolution Detection Technology and Leak Remediation with Pressure Activated Sealant – A Case Study**

Azamat Kantarbayev and Tilek Jumamukhambetov, NCOC N.V., Atyrau, Kazakhstan

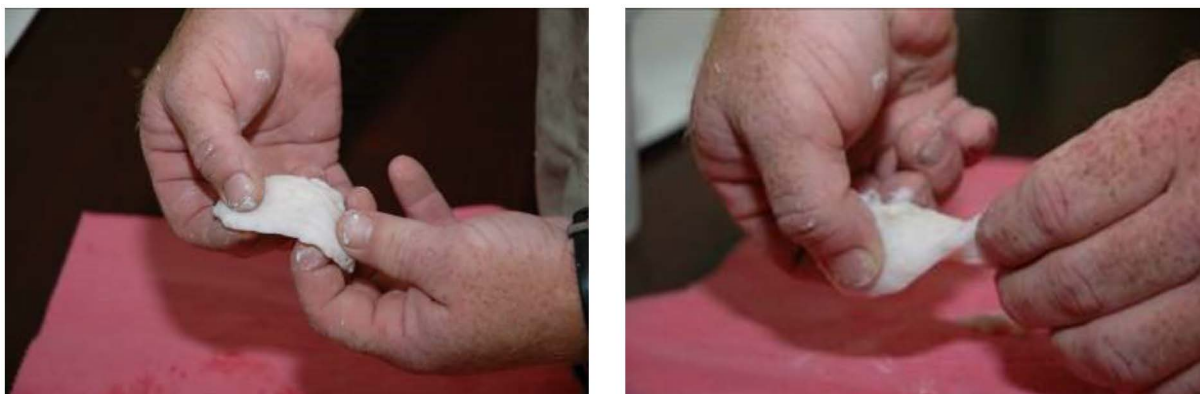
Figure 4—Photo of polymerized sealant sample

Based on laboratory testing and sealant composition, the polymer gel (sealant) is designed to polymerize only once it has reached the trigger differential pressure of 500 psi. This pressure drop is inherent to leaks

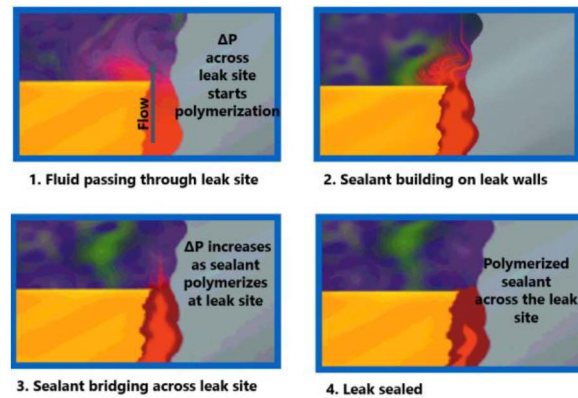
at large, and as such, any sealant not exposed to the leak site will remain in the liquid phase indefinitely, unaffected by the temperature, system pressure, or the time that the sealant remains in the system. Once polymerized and cured, the sealant forms a flexible solid mold into the contours of the leak site to restore pressure integrity. The resultant seal will remain solid and cannot revert to a liquid state. The polymerization process is illustrated below.

Figure 5—Polymerization process of pressure activated sealant

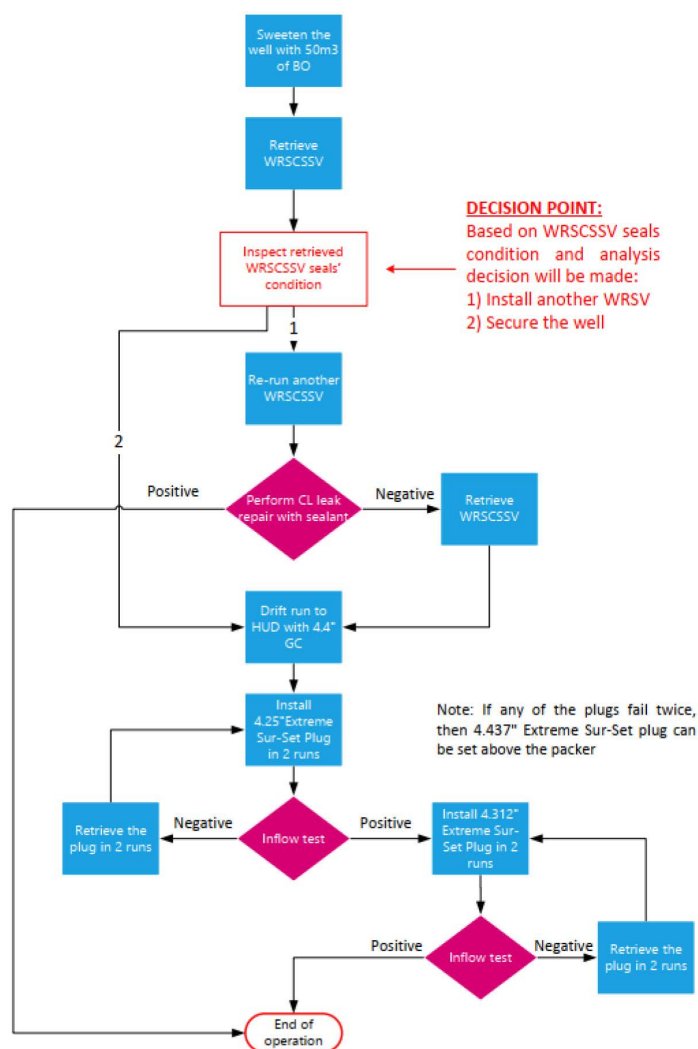
Decision tree below shows the planned steps for operational execution in Spring 2022.

Note that drift run with 4.4 in Gauge Cutter (GC) prior to installation of 4.312 in plug is required in case if we must secure the well. This GC size also addresses the installation of 4.25 in plug. The prudent approach is to optimize with a single run to be ready for both options.

Figure. 5a—Well intervention scenario planning
