**SPE-228278-MS**

## **Use of Pressure-Activated Sealants to Repair Leaking Subsea Horizontal Tree Connectors (Unlatch HXT)**

A. Burgess, Seal-Tite International, Madisonville, LA, USA; S. Carpenter, Santos Pty Ltd., Perth, Australia; C. Anderson, Seal-Tite International, Madisonville, LA, USA

This paper was prepared for presentation at the SPE Subsea Well Intervention Symposium held in Galveston, Texas, USA, 19-21 August 2025.

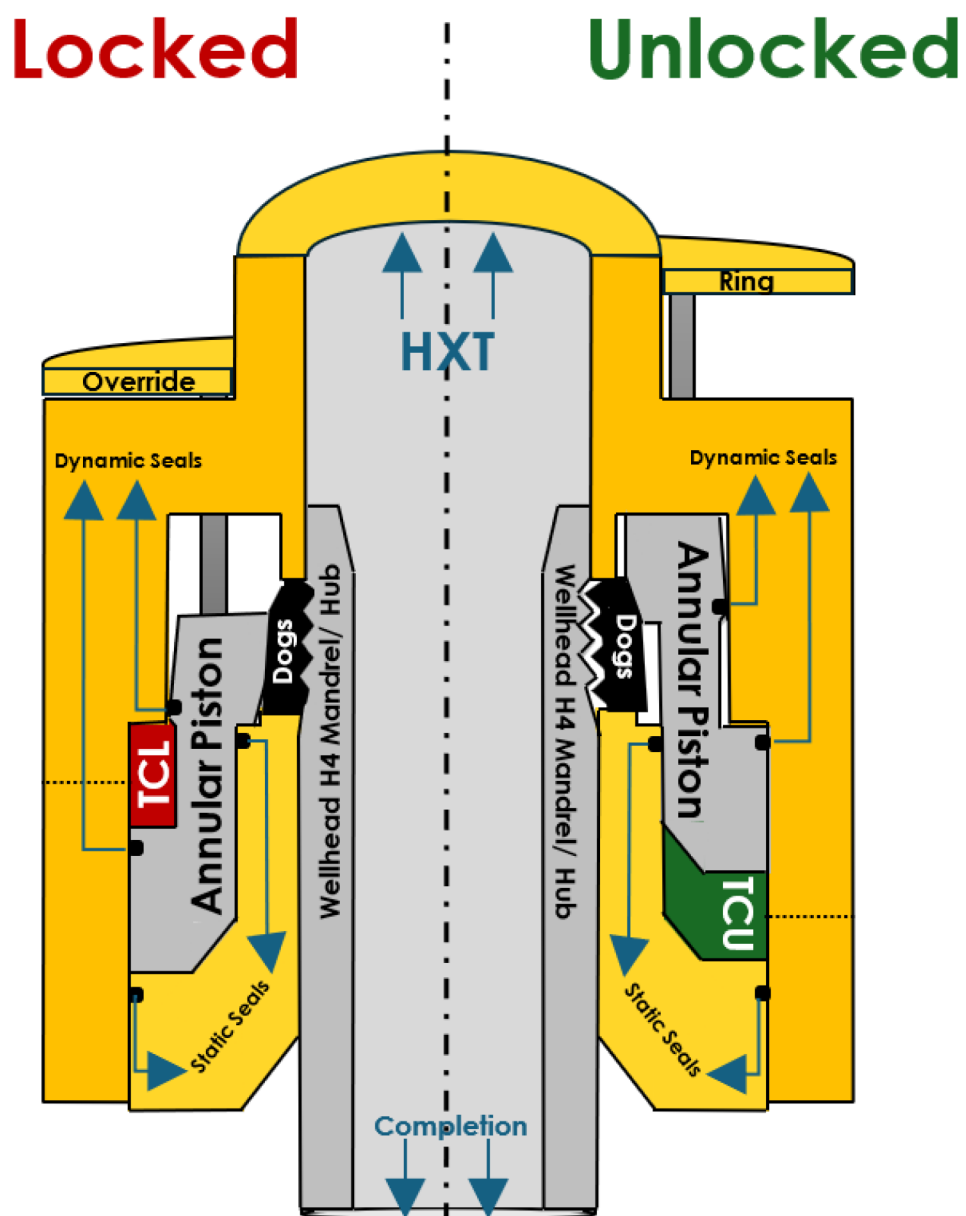
Figure 1—Simplified H4 Connector Visual Representation

The H4 connectors in question were designed with a single annular piston which could be hydraulically stroked downwards via the TCL system to lock the tree in place, or upwards through the TCU system to unlock the tree and allow its removal (See [Figure 1](#)). A combination of static and dynamic elastomeric seals arranged on both the annular piston and connector body serve to isolate the lock and unlock chambers to facilitate piston movement according to the desired action. In the lock position, the geometry of the annular piston is such that the locking dogs are engaged against the hub. Conversely, as the connector is unlocked, the piston profile allows the dogs to retract, and due to the interface of the locking dogs on the hub profile, allows the tree to be pulled.

Given the inability to use conventional means to unlock the connector, the operator was left to determine a forward path. The TCU side of the annular piston features an effective surface area of approximately 610 in<sup>2</sup> and a typical unlocking operation could involve application of up to 3,000 psi, its maximum working pressure, which would deliver approximately 1,830,000 lb/f. Industry advice, however, suggests the connector design would be expected to commence unlocking in the range of 1,000 psi to 1,200 psi for connector installed subsea over long durations. Some of the HXTs designs featured a override system interface, essentially guide rails, which allowed a jacking system to be placed below the override ring load transfer blocks and apply external force to manually function the piston (See [Figure 2](#) below). This jacking system was composed of three (3) separate cassettes, each featuring three (3) hydraulic jacks, comprising a total effective piston area of 99 in<sup>2</sup>. Structural limitations within the system enabled a maximum pressure of 7,100 psi to be applied to the nine (9) jacks to deliver a maximum force of approximately 702,900 lb/f. The force resultant from these jacks is theoretically sufficient to unlock the connector, however, as the operator would observe throughout the campaign, additional factors limited the success in the application of the jacking system. Throughout the development of the campaign, the bespoke jacking system was only utilized successfully in 2 cases, although it was installed on all HXT's featuring override rails, to function as a supporting mechanism for the operator's selected primary approach: restoration of connector hydraulic integrity.

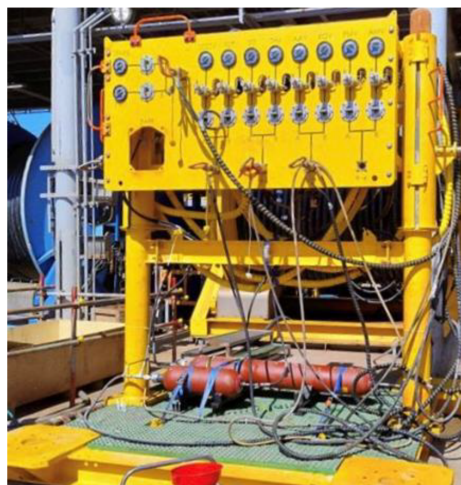
Figure 3—Photo of Retrofit RWOCS Panel Bladder-Accumulator Skid

With the proposed pressure-activated sealant approach accepted, the provider and operator worked together to develop the necessary equipment spread to implement the repair procedure. The connector TCU had a roughly 16L fill volume, with an additional 40L stroke volume. As time was critical, a RWOC panel skid present on the rig was retrofit to attach 2 bladder-style accumulators of 20L and 50L volumes (Pictured in Figure 3). The shell side of the two accumulators would be filled with two distinct blends of pressure-activated sealant, while the bladder would serve as a piston, displacing sealant as it would be filled with water-based control fluid.

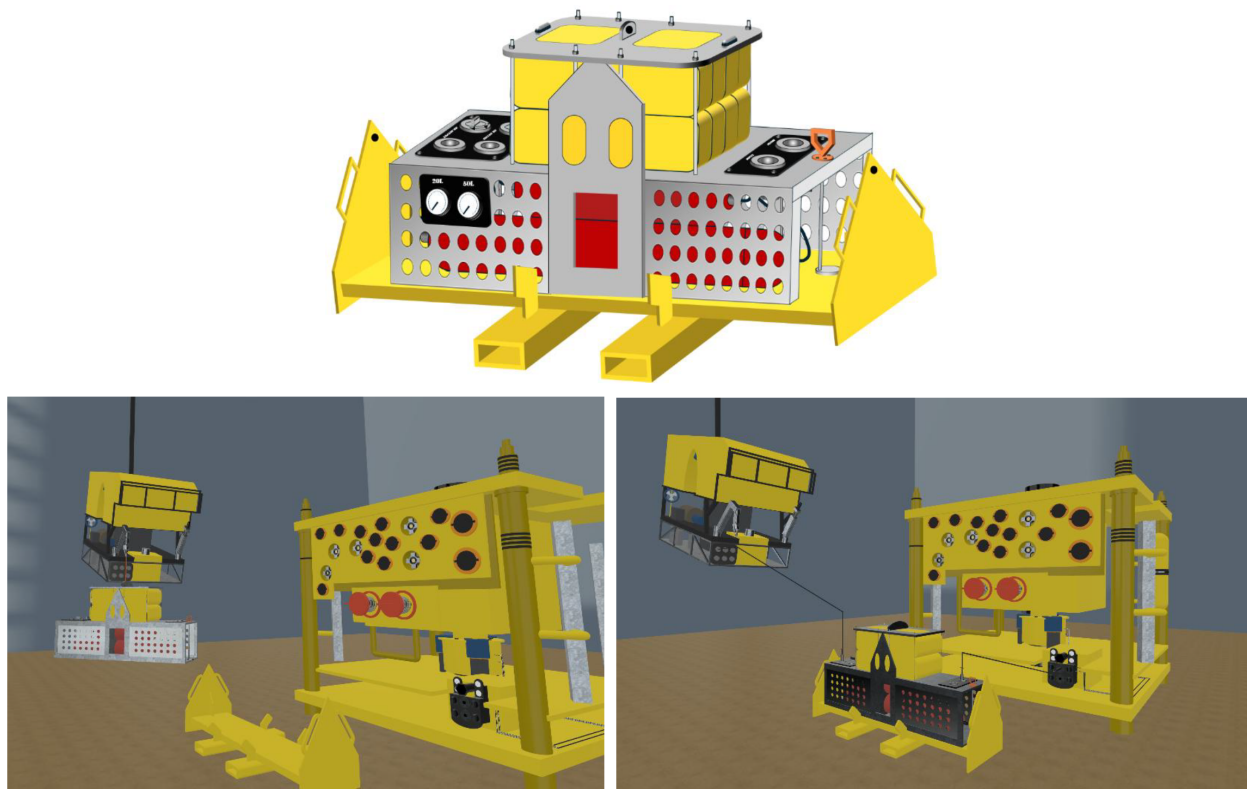
Figure 5—(a) Purpose Built Subsea Sealant Injection Skid Drawing; (b) Rendering of ROV-Skid Maneuverability and Interface

Following the successful HXT removal on the 2<sup>nd</sup> and 3<sup>rd</sup> connectors, the operator designed and manufactured a purpose-built skid to help simplify the subsea operation. This skid featured a smaller footprint, flushing circuit, skid mounted pressure gauges, and isolation valves not present in the RWOCS panel skid. Additionally, the skid comprised of two major components, a base and an accumulator housing. The design was such that the ROV could turn a handle and release the housing from the base. Housing weight and buoyancy was allocated to allow the ROV to then carry the skid to a desired location and work on a connector with the rig engaged on a different well.
