A unique array of pressure activated sealants

By Jed Doubenmier, Seal-Tite International

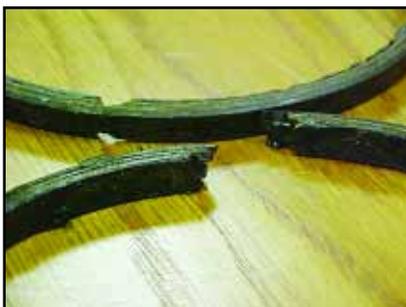
Once the well had been suspended, the riser was pulled to the leaking connection and the damaged seals removed for inspection. Above is a photo of the polypack seals. It can be seen that one of the seals was completely separated while the second seal had significant damage to the sealing areas. ■

Subsequently, Seal-Tite was contacted to diagnose and repair a leaking drilling riser choke line in 5,795 feet water depth in the Gulf of Mexico. Using dye and ROV inspection, the leak was identified as a connection at 4,275'. The leak rate was 8.5 gallons per minute at 2,000 psi injection pressure. The high leak rate was further aggravated by loop currents exceeding 2.6 knots.

A 2.5 bbl sealant pill was displaced to the leaking connection with seawater by circulating down the choke line and taking returns on the kill line. Once in position the BOP crossover valve was closed and sealant was squeezed into the leaking seals. Over the next 12 hours the sealant injection pressure was steadily increased until an 8,000 psi seal was achieved. This pressure was held for 8 hours to allow the sealant to cure, during which no pressure bleedoff was observed. The sealant was then flushed from the system and the choke line tested to 7,500 psi, allowing normal drilling operations to resume.

The leak was repaired and the client was able to complete drilling operations over the next 30 days with no further riser-related downtime. The choke line riser was successfully tested to 7,500 psi every three days for the duration of the drilling operation with no leaks observed.
